MELLING COLLISION

15 April 2013

EXECUTIVE SUMMARY

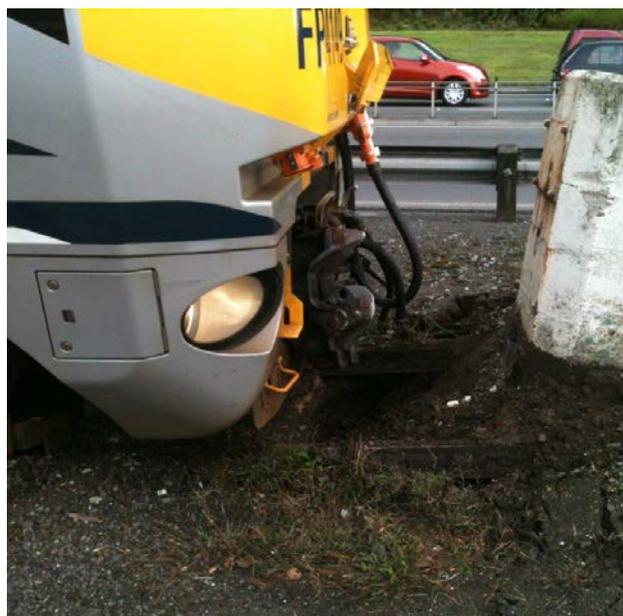
- There was no mechanical fault on the Matangi unit which collided with the stop block at a speed of approximately 25km/h.
- All of the unit's components - brakes, coupling, and catcher - functioned correctly as they were designed.
- The driver had applied braking which was insufficient to stop the train and applied the emergency braking system immediately before impact with the stop block.
- The data downloaded from the train's Tranzlog (the equivalent of the black box on an aircraft) showed that the braking systems operated as they were designed.
- Therefore the cause of the incident was driver error.

At 7.54am Train Control was informed that 5618 had failed to stop and had collided with the stop block at the end of the Melling Line.

The driver said that the braking had failed and the emergency braking had no effect.
