# Northland Rail Programme Newsletter

## Recent weather impacts on the North Auckland Line

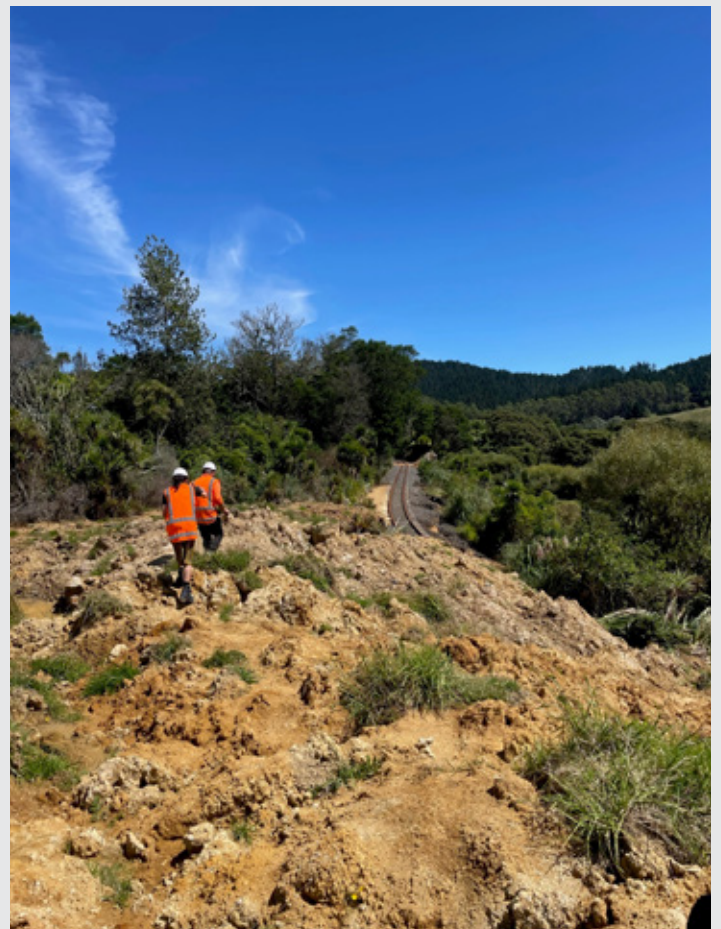
The biggest issue is a 350m slip at Tahekeroa, between Helensville and Wellsford. In late January this saw more than 35,000 cubic metres come down across a road and the rail line below. Before we could take action, the slip needed to stop moving – which wasn't helped by further rainfall in the following weeks.

*Tahekeroa Slip – ground level*

The slip has been assessed by geo-technical experts and we have now begun enabling works and started to clear material. In the weeks and months ahead we will:

- Build an earth bund above the road, to ensure safety while we clear the majority of the slip.
- Build a permanent, engineered bund to help control any further slips; dig out a catchment area between the road and rail in case earth does go over the bund; and ensure there is excellent drainage in the area to reduce the risk of more slips.

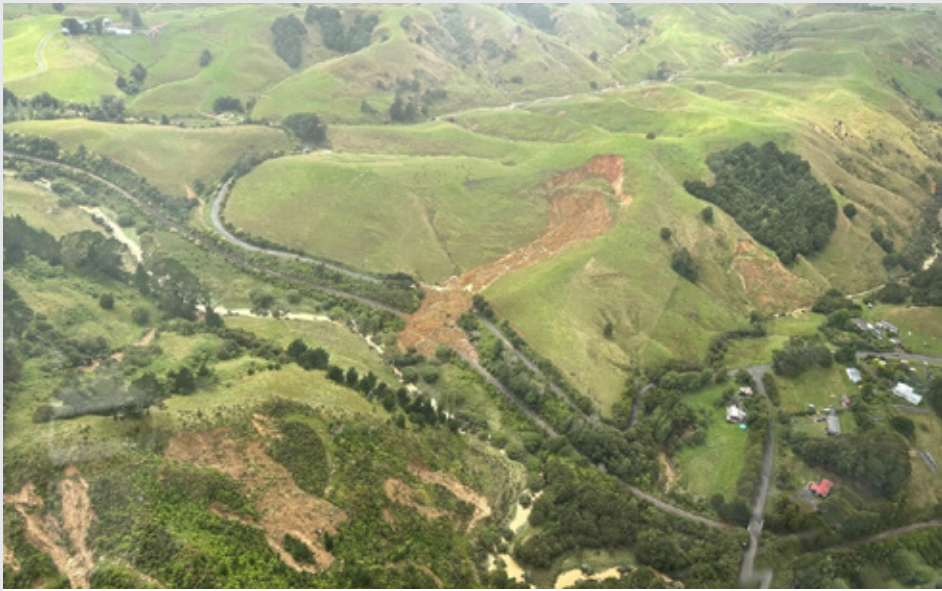
*Aerial view of the massive slip in Tahekeroa*

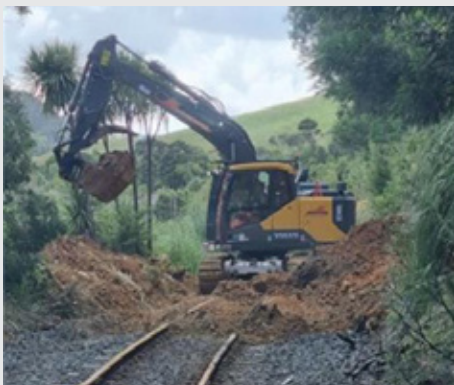
*Small slip on the NAL*

There have been at least 50 slips on the line. While we can quickly clear away debris in many, we need to undertake engineering assessments and take steps to ensure there are no further slips in the future. These assessments and response are ongoing.

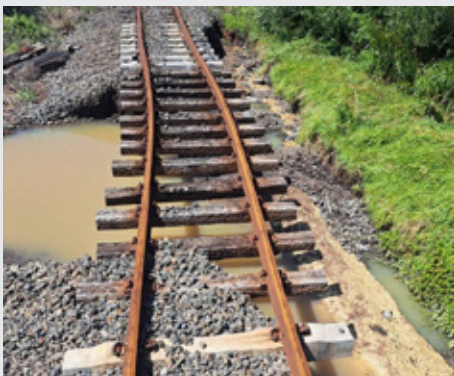
*Washout on the NAL*

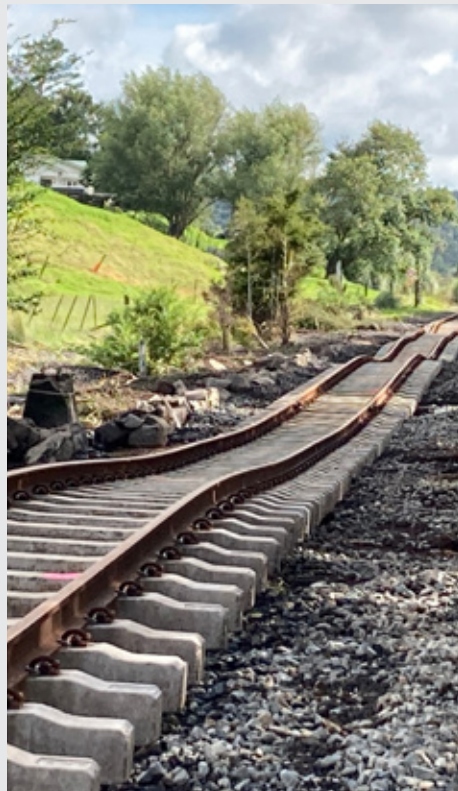
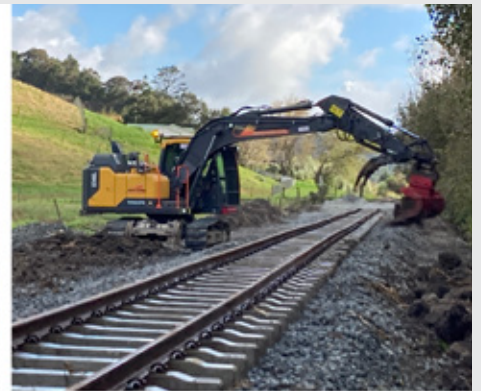
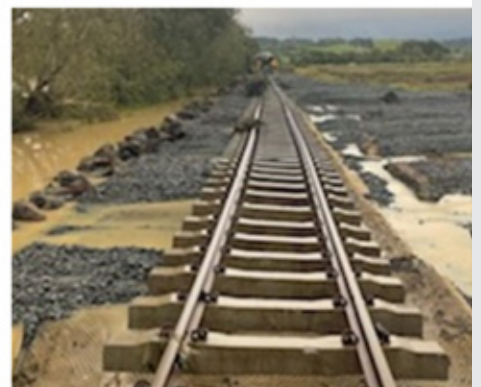
We've been working hard to clear debris and repair damaged track. While we are making good progress, the ongoing weather recently has hampered the response. For example (see pictures below), the rail near Kaukapakapa was damaged in the 27 January event, with repairs near complete when severe localised rain and flooding hit on 24 February. The new rail and formation (the rock foundation under the track) remained intact, but the unconsolidated ballast was washed away. Further repairs are underway.

*Rail damage near Kaukapakapa: track damaged after the 27 January flooding (left); repairs underway (top right); further damage in the 24 February weather event (bottom right).*
