Northland Rail Programme

May 2023

Progress repairing the North Auckland Line

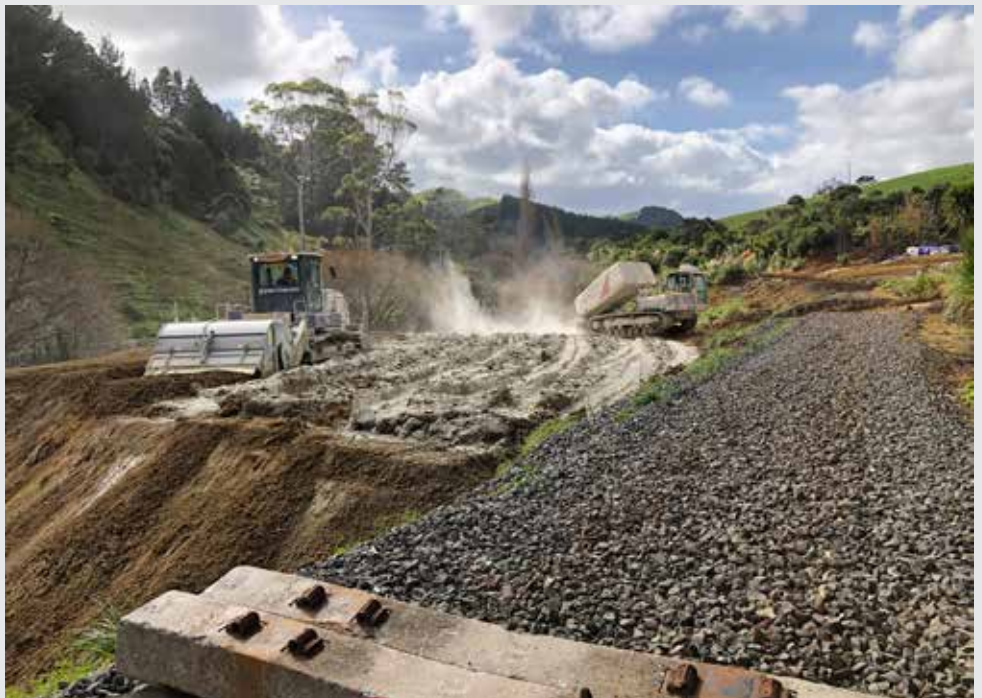
The rail corridor at Tahekeroa has been cleared and landslip material is being stabilised at a temporary fill on site beside it.

At Tahekeroa, the foundations for a temporary earth bund above the road are complete and work is progressing to construct the bund that will protect the downhill works against further movement of the landslip. Earth from the debris flow is being stabilised on site for re-use within the final design.

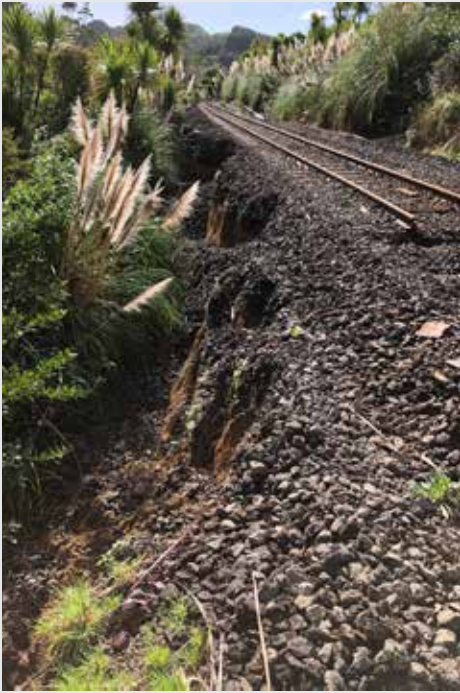
Example of an underslip near Tahekeroa

drains and re-stabilising saturated slip material with lime. There has also been an underslip beside the rail line that will need an engineering response, to ensure safety.

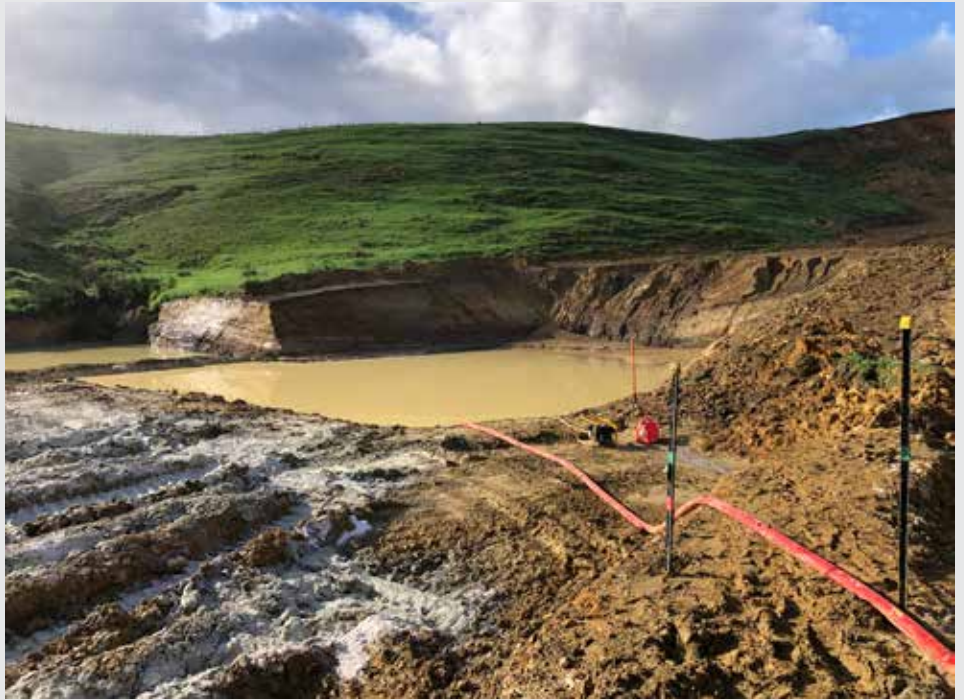
Example of ongoing weather impacts - having to drain water from excavations at Tahekeroa

This has required ongoing site tidy ups - such as pumping water out of excavations, clearing silt from

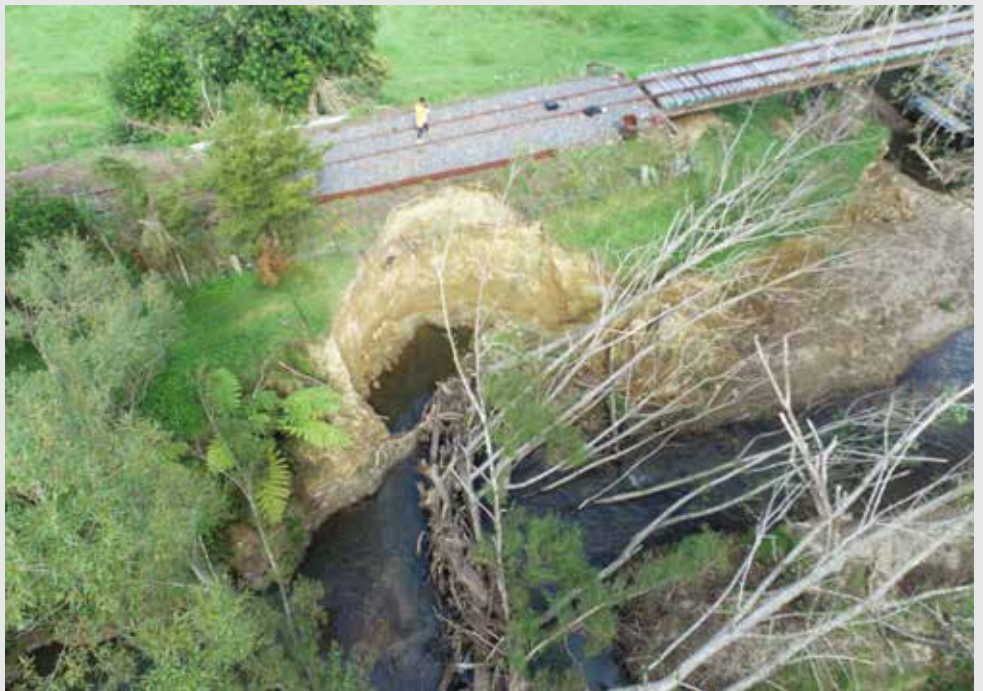
Example of river scour near Whangārei

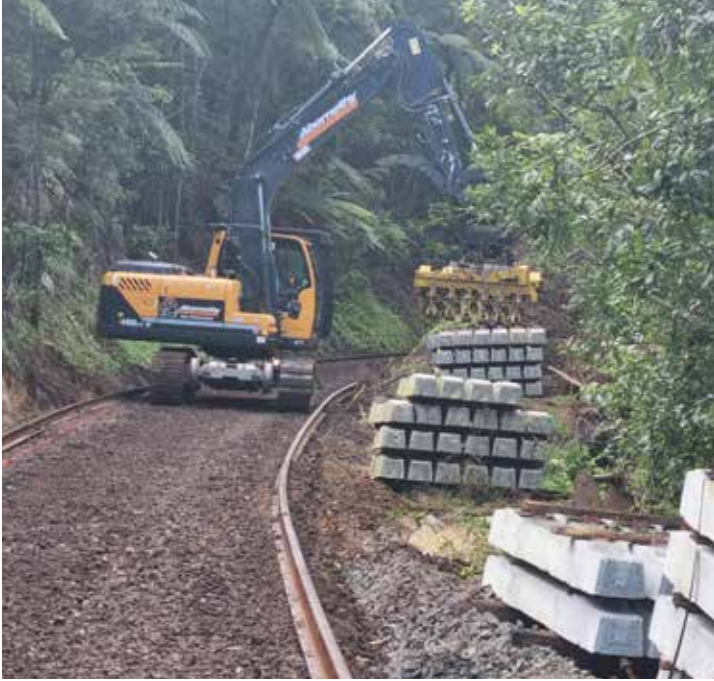
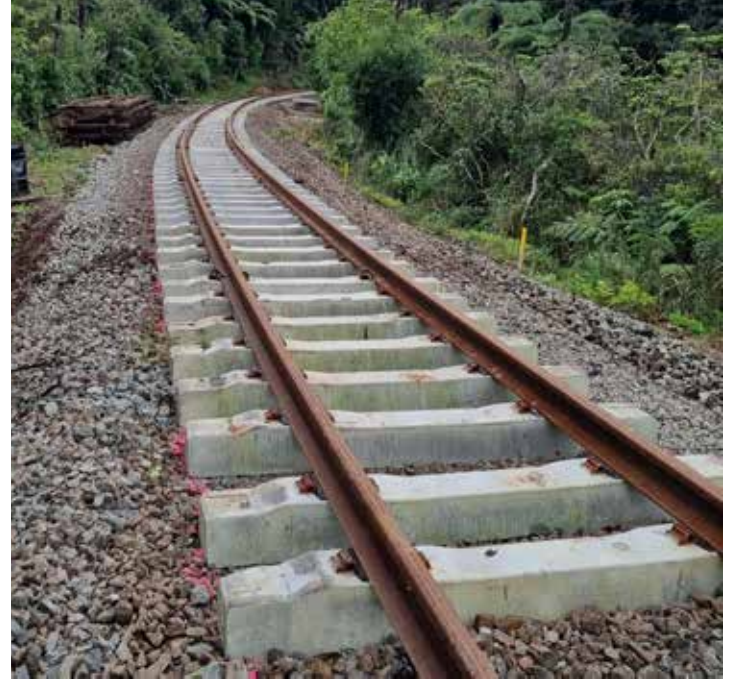
New rail and sleepers being installed between Waipanga Road and the Kauri siding

So far we have laid 4,460 new concrete sleepers – some of which were supplied by Busck in Whangārei - to replace life expired timber sleepers. We have also laid 2.9km of new rail laid.

This work will raise the standard of the track to handle heavier trains (18 tonne axle loads). The aim is to complete as much renewal work as possible before the NAL reopens, to avoid further disruption for customers.

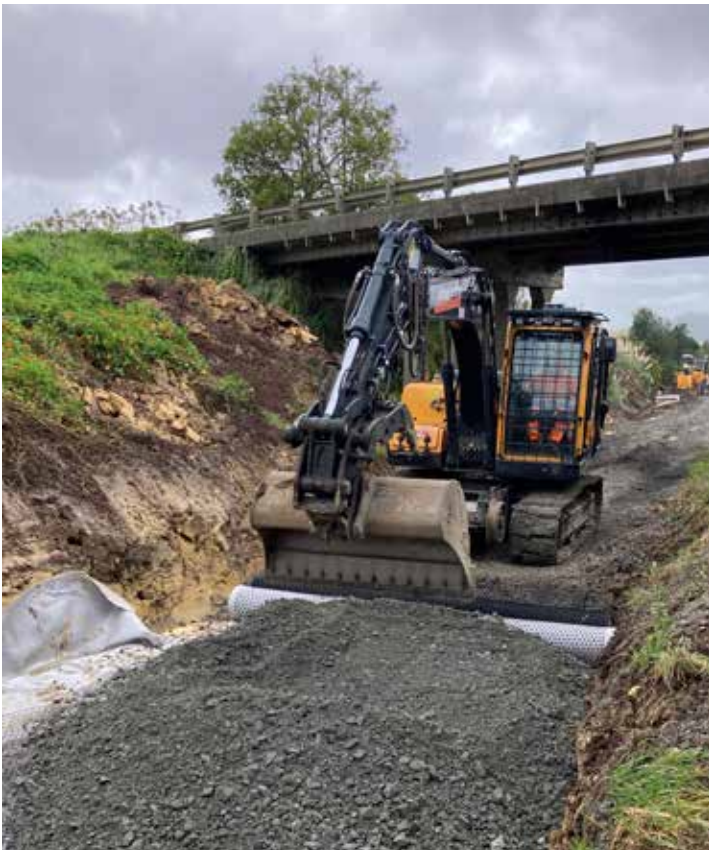
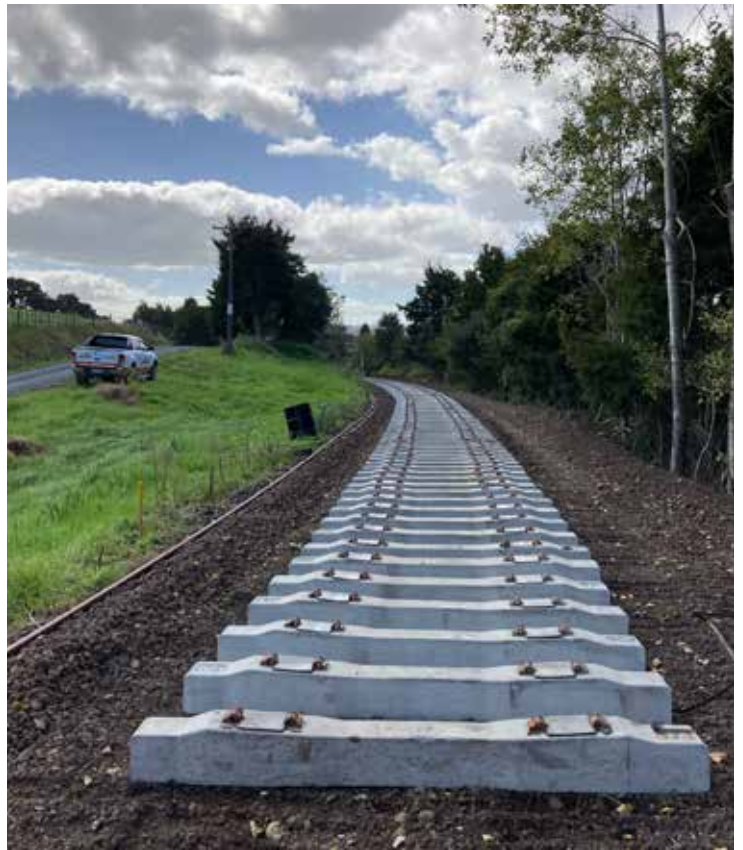
Rebuilding the track foundations and laying new sleepers near Kauri
