August 2023

Northland Rail Programme

Progress repairing the North Auckland Line

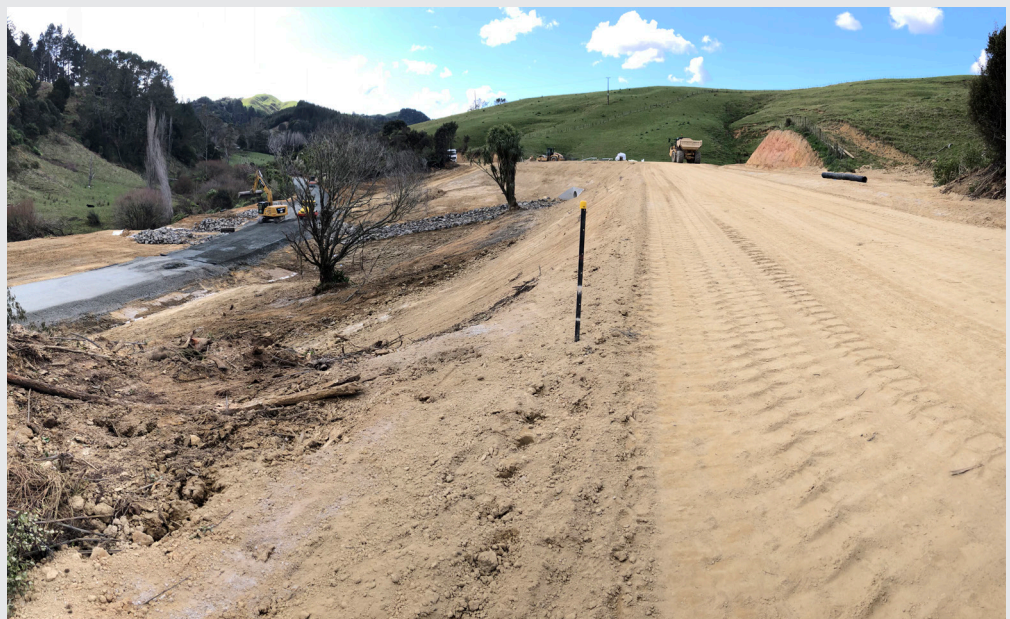
Tahekeroa - the 4m-high raised road just before surfacing began

At Tahekeroa (86km mark), good progress has been made through a wet August:

- Construction of the road embankment, with a finished level of nearly four metres over the culverts, is now complete and final surfacing and water table trimming is underway.
- Laying new rail formation is complete and track installation is underway.

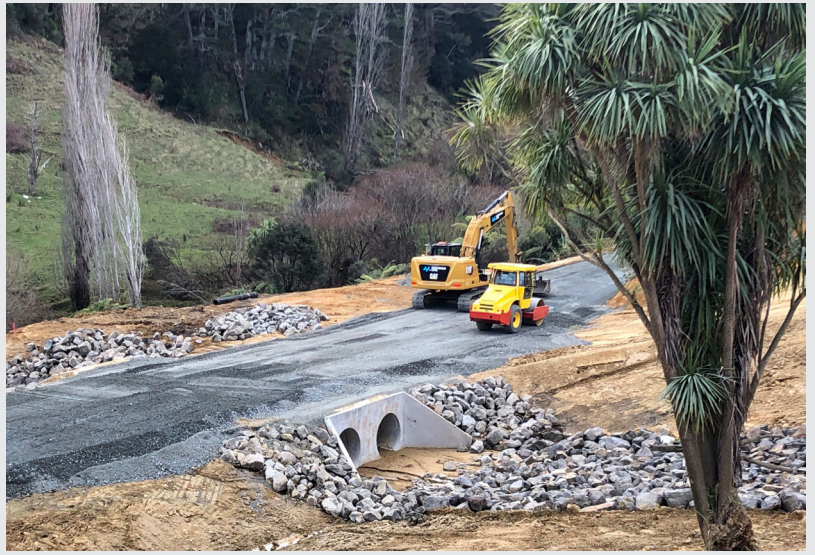
Takekeroa - rail formation being re-laid

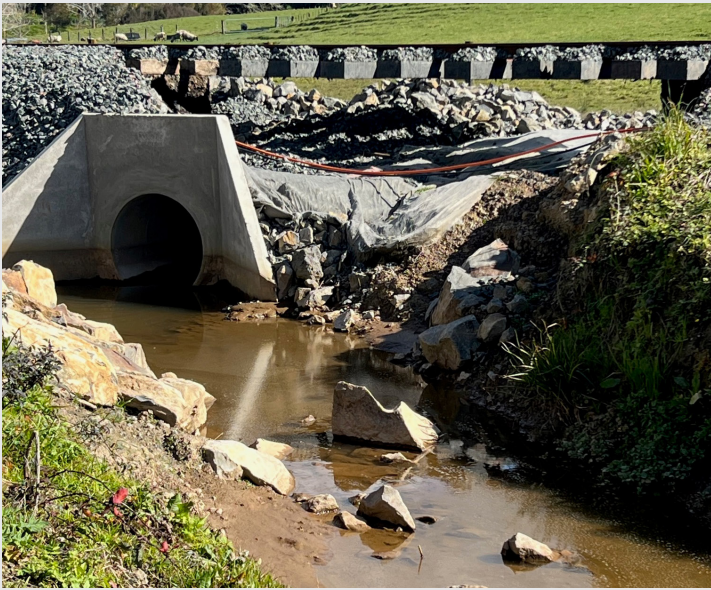
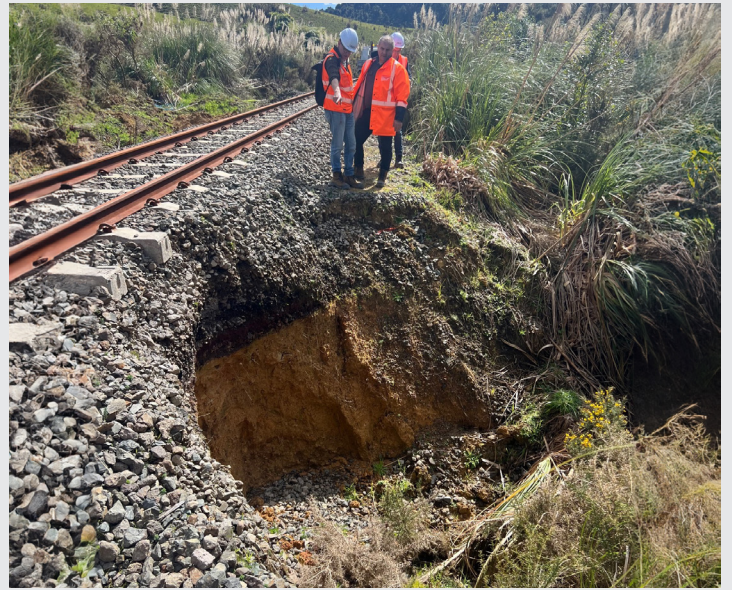
Examples of damage sites getting worse over winter: an overwhelmed culvert and a washout beneath the tracks, both south of the Kaipara Flats

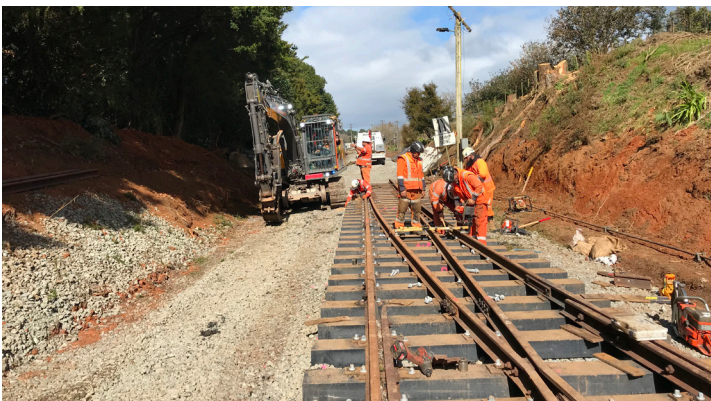
A turnout being built to connect to Fonterra's siding at Kauri

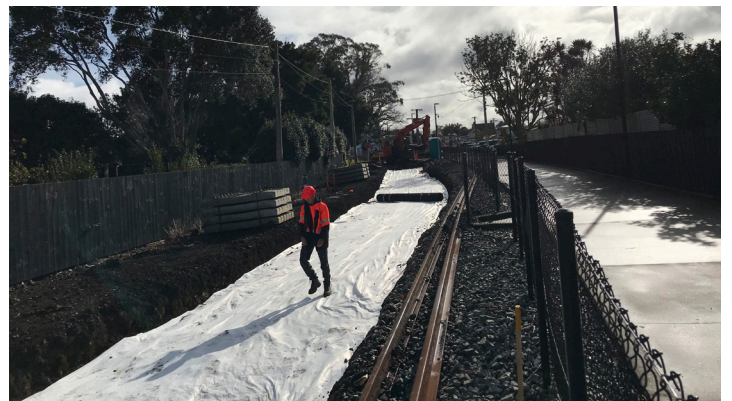
Preparing the formation bed between Manse Street and Vinery Lane in Whangārei
