Hawke's Bay Cyclone Gabrielle Rail Recovery

Hastings - Napier progress

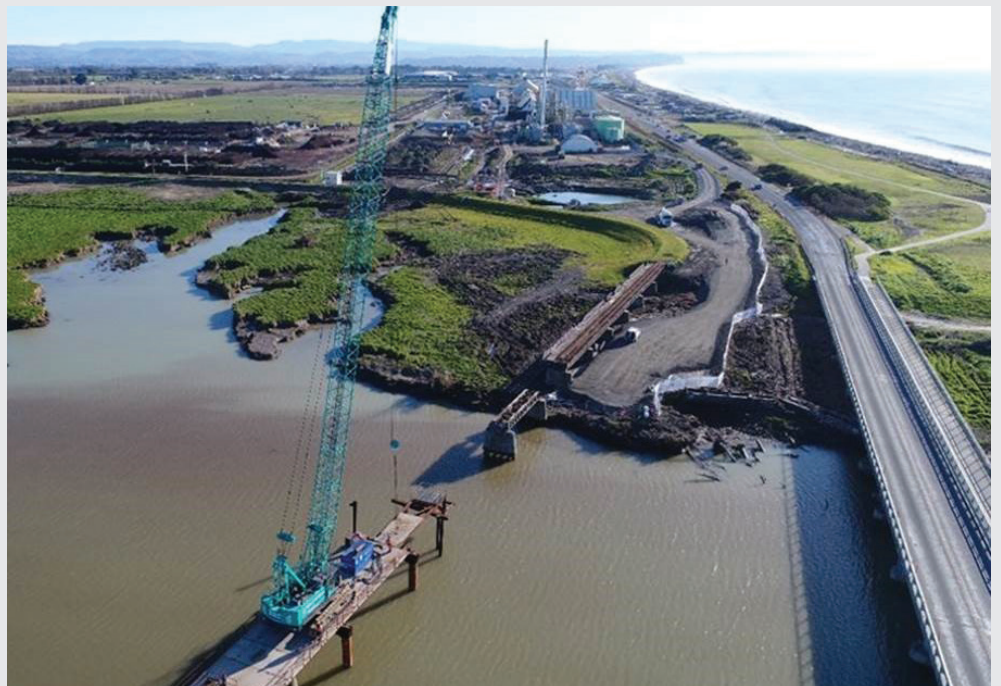
Good progress on temporary repairs to Bridge 217, Awatoto (south of Napier)

With damaged parts of Bridge 217 removed, over the last month we have made excellent progress on temporary repairs to that structure.

Using steel casings, which were railed from Christchurch up to

Hastings, our contractor has driven 10 of the 12 piles from the south riverbank and installed temporary works on these to allow the construction of the headstocks. A crane pad has also been built on the north side of the river, to allow for time savings by completing the northern most piling and span

installation from that side. The pier works will be followed by the installation of temporary rail spans from KiwiRail's "spare span" stocks, which are kept for emergency works like this.

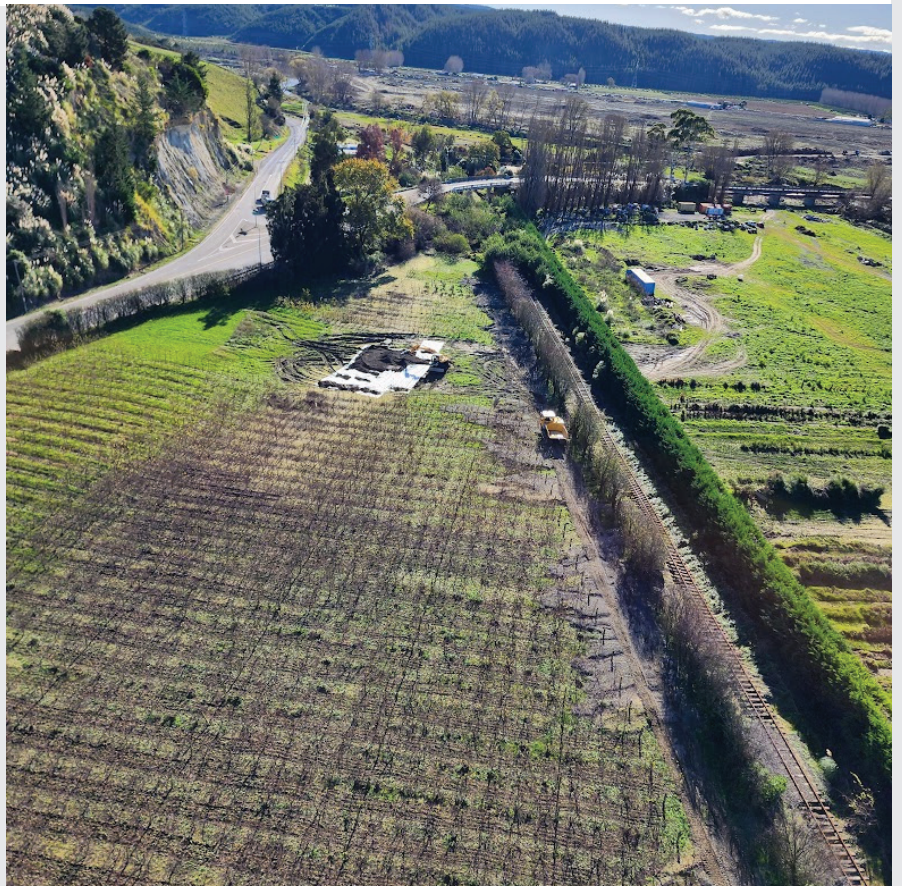
'Make safe' work between Napier and Wairoa - clearing ballast that had washed off the rail line, blocking culverts, in Bayview

The focus of our physical works at the moment, is on "make safe" works – such as clearing culverts and drainage pathways, removing ballast that has been washed off the rail corridor, clearing tunnel portals and clearing debris away from rail bridges on the line. This is about making the corridor safe and reducing the risk of further weather damage over winter.

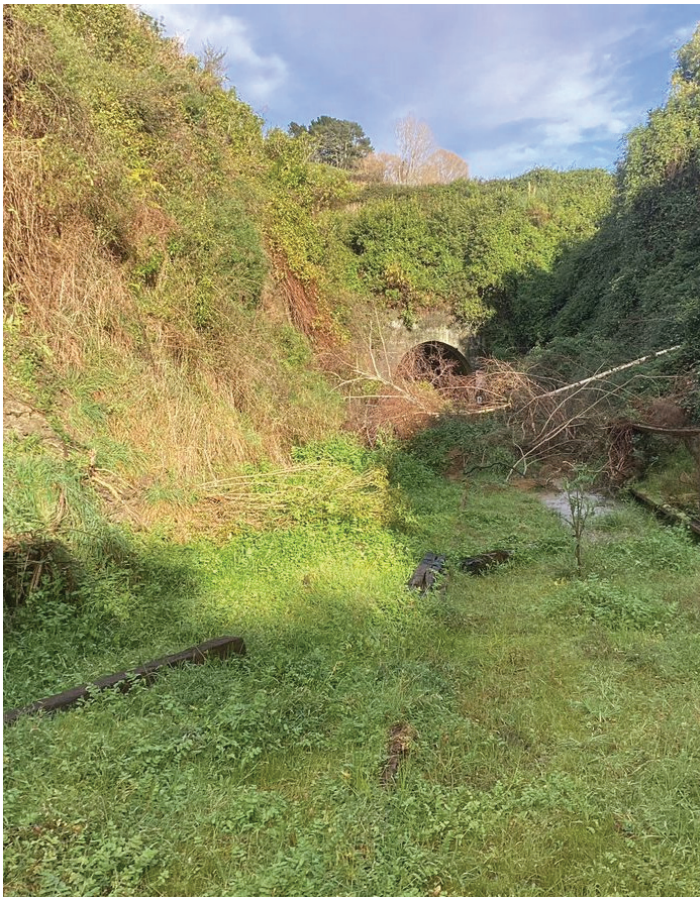
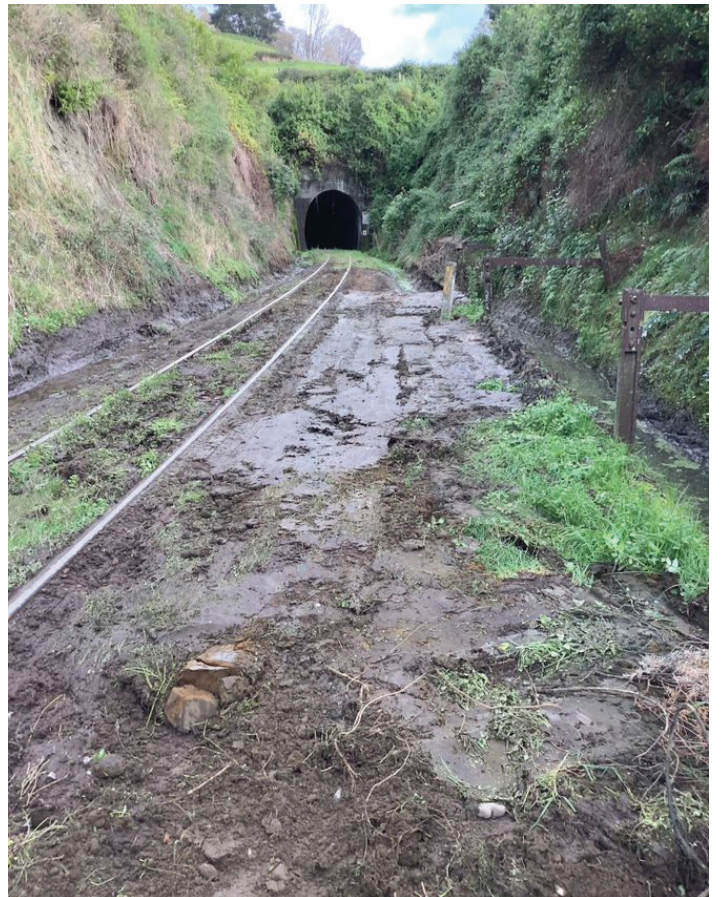
Clearing the portal to Tunnel 9, at Kotemaori – before (left) and after (right)

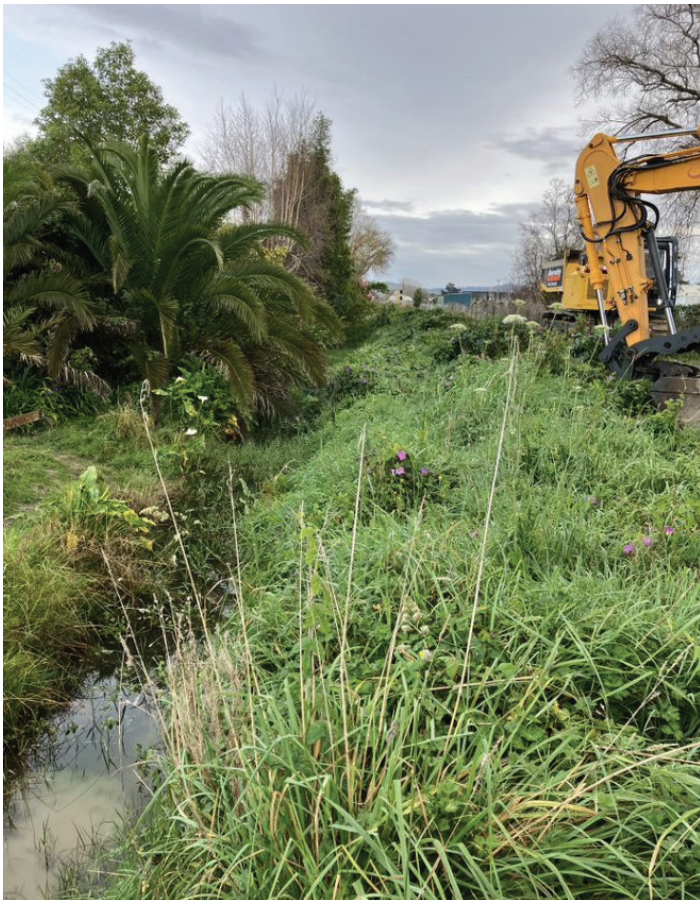
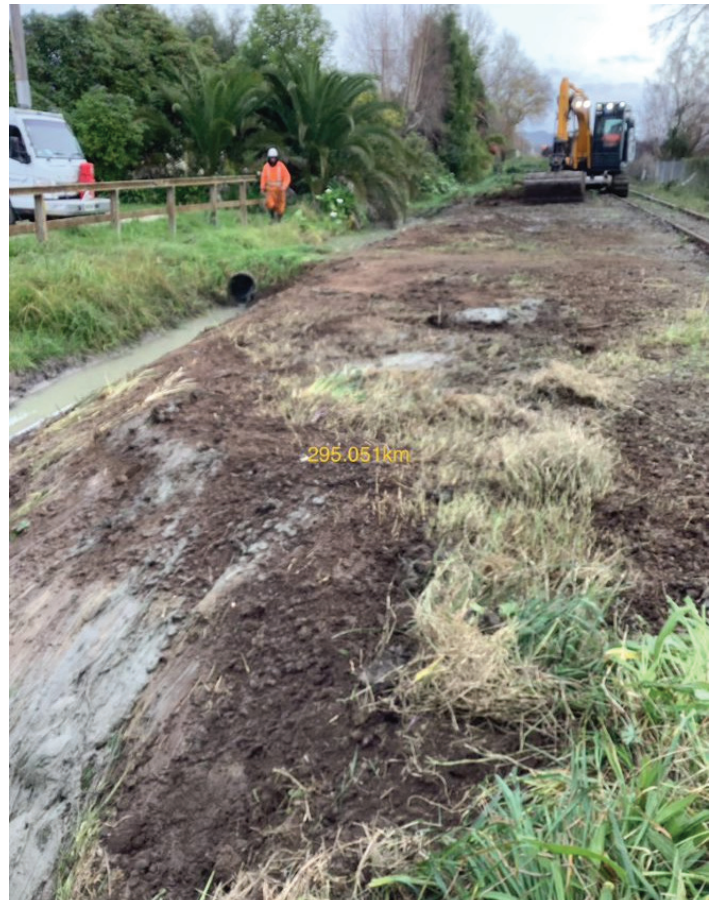
Clearing drains next to the track near Wairoa, to lessen flood risk over winter – before (left) and after (right)
