Northland Rail Programme

August/September 2024

Progress repairing the North Auckland Line

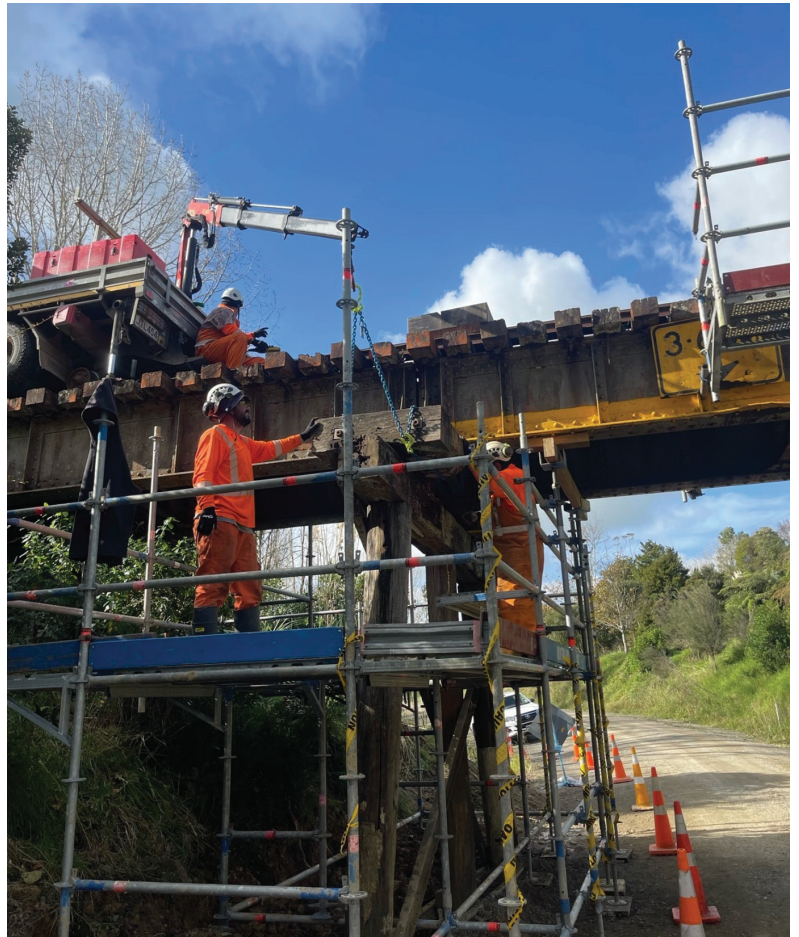
Work replacing a corbel on Bridge 140, Maungaturoto.

Completed repairs to the 28 bridges between Kumeu and Kauri have included replacing piles, piers and corbels (which transfer weight within the bridge structure). In addition to KiwiRail's structures teams from other parts of New Zealand, specialist contractors were also brought in to assist with the work.

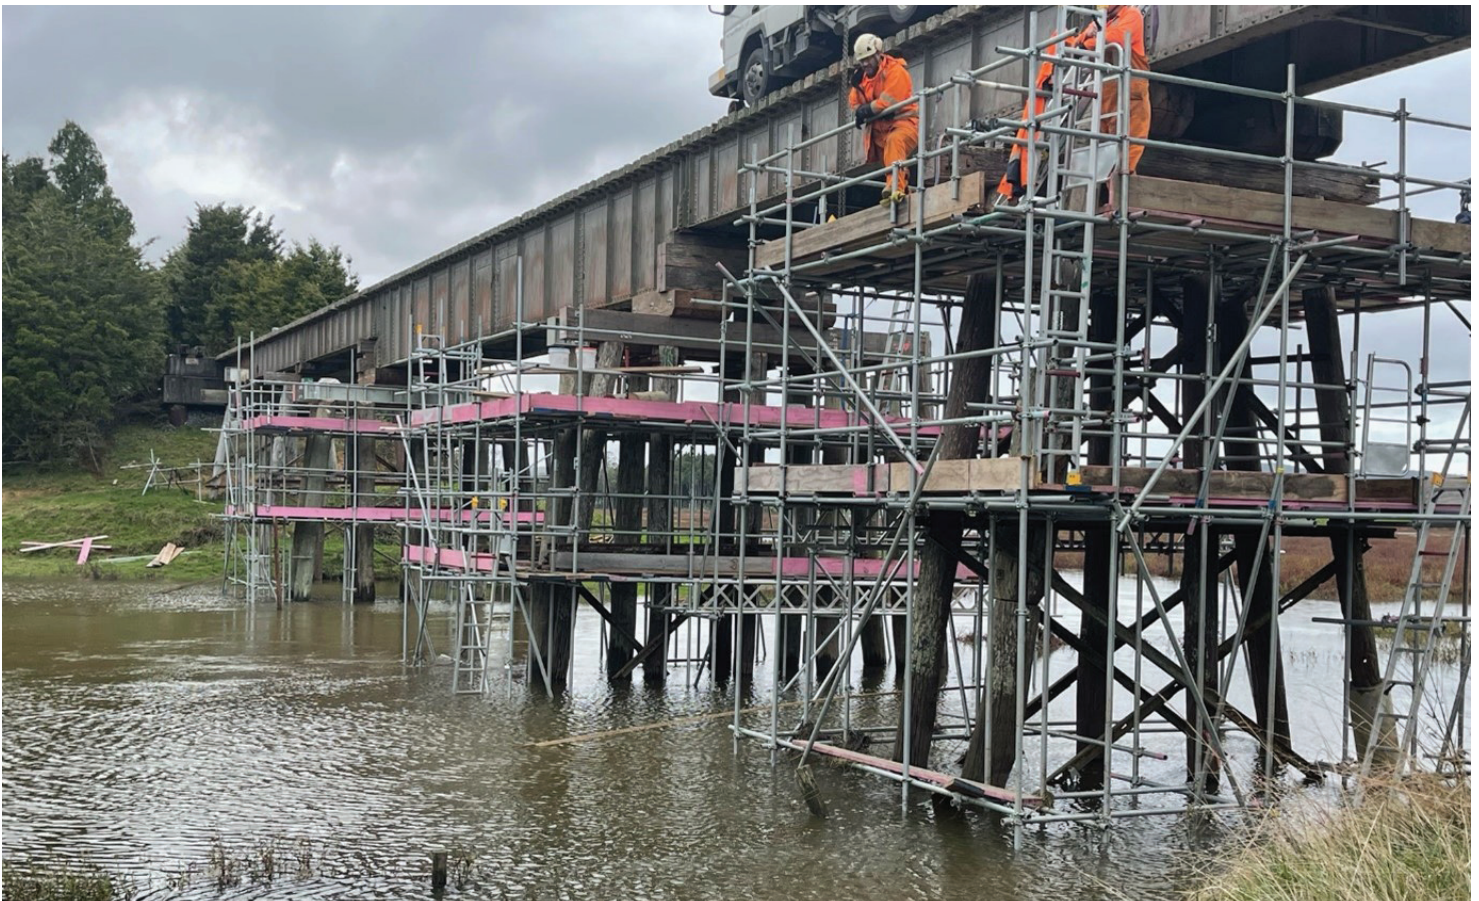
A range of work is being undertaken on Bridge 150 at Paparoa, including on piles and corbels.

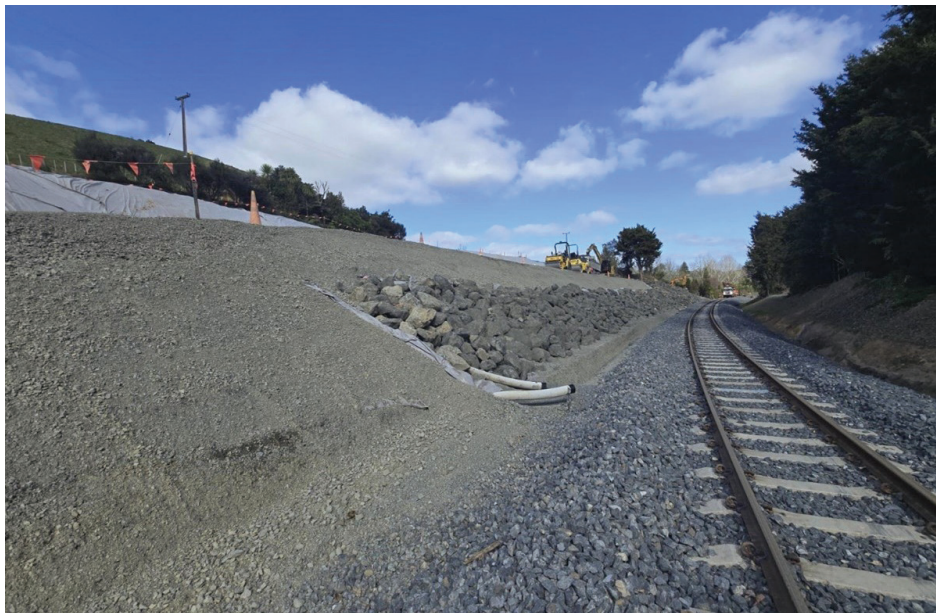
An example of a remediated site near Tahekeroa, where a slip prone hillside was excavated and an engineered rock structure (left of picture) built.

There were a number of significant slips around Tahekeroa, north of Helensville. Fixing them involved clearing slips and excavating spoil so that engineered structures could be built. These included stacked stone embankments, retaining walls, drainage improvements, and other solutions to repair the damage and protect the rail line from future slips.

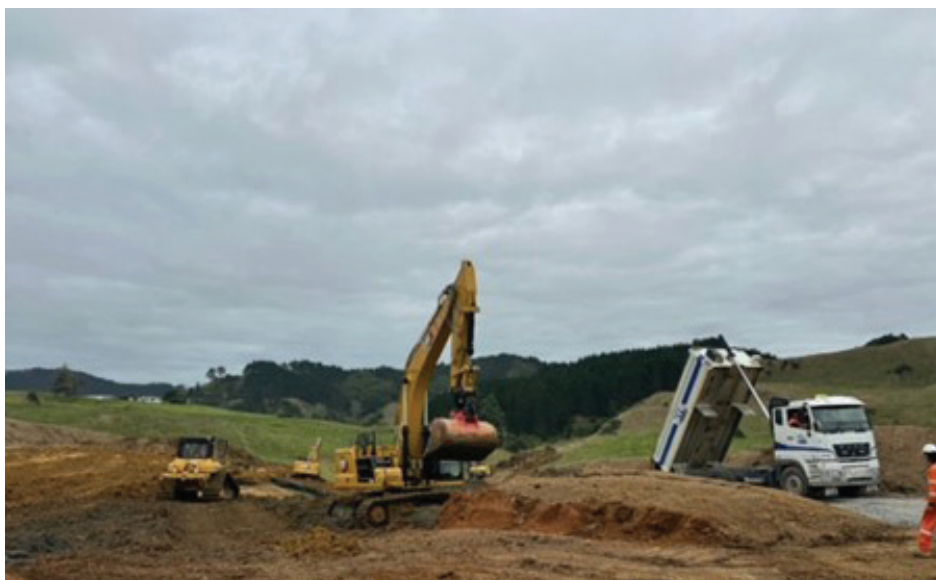
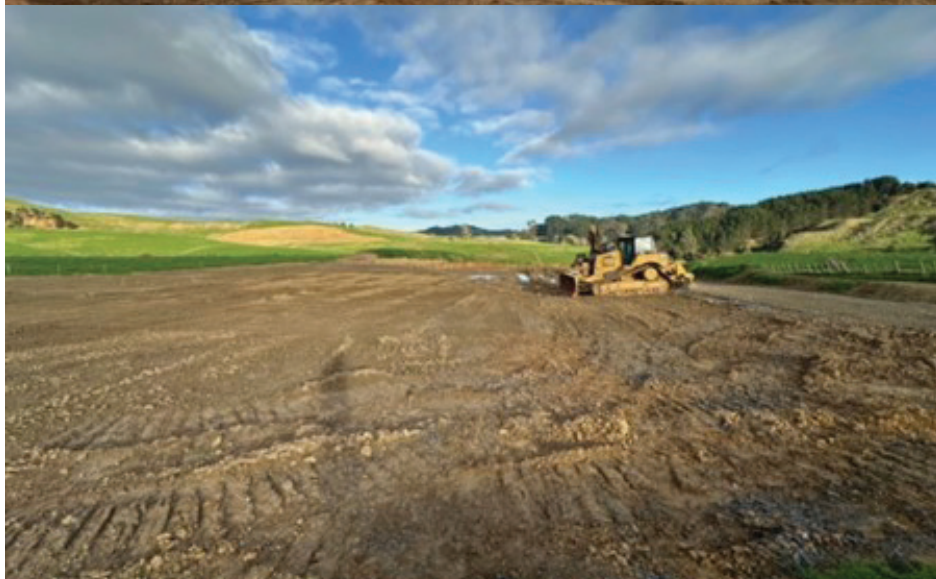
Depositing earth and levelling the farmer's paddocks.

Since March we have been working with a local farmer and rail corridor neighbour to deal with this material. With their support we have been depositing the earth on their farm.

And we have been able to improve the farmer's land, making previously difficult to access areas productive and accessible.
