Our work repairing the 180km North Auckland Line (NAL) will be picking up pace over the Christmas break with work getting underway on a number of major damage sites.

Progress repairing the North Auckland Line

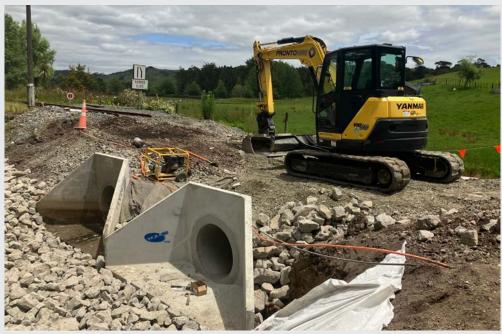
New culverts, to improve water flows, being installed under the rail line in the Kaipara Flats area.

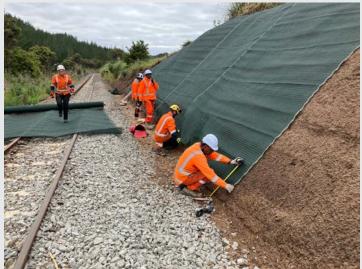
Stabilising mesh being added to a cleared embankment beside the track near Topuni.

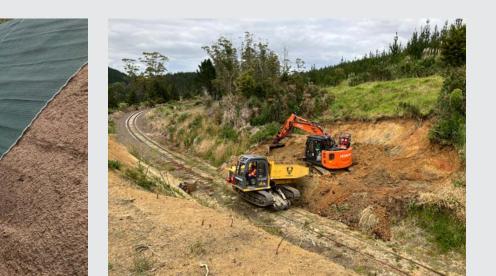
Another slip being cleared near Topuni.

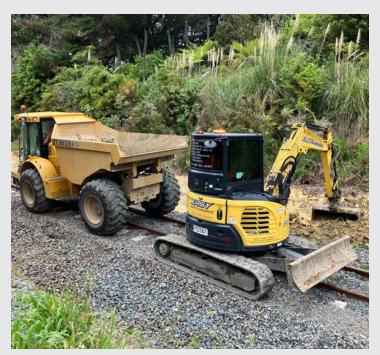
A swale drain being cleared near Maungaturoto.

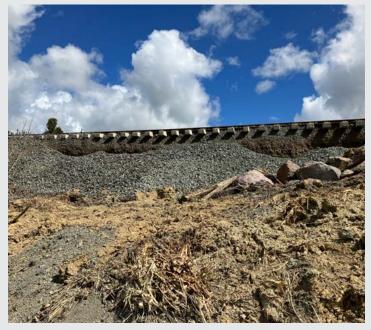
A major damage site near Topuni, which will be worked on over the Christmas break. Land under the rail line has collapsed and the entire 47 metre high slope will need to be retained, along with a new, larger culvert.

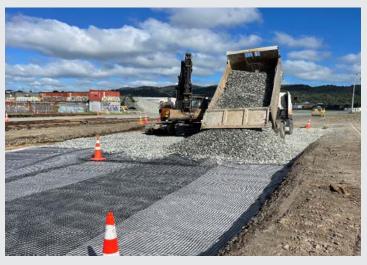
Upgrades to the Whangārei Rail Yard – old track foundations have been dug out and removed, geo-mesh put down and new rock laid. It is then compacted before the rails and track structures are reinstalled.

As previously mentioned, we have completed Government funded track replacement and upgrade work between Whangārei and Kauri, which will allow heavier trains to run on the line. While the NAL is closed, we are now taking the opportunity to carry out upgrade work in our Whangārei Rail Yard. Doing this work now means we avoid any further disruption to customers later on.
