Northland Rail Programme

Progress repairing the North Auckland Line

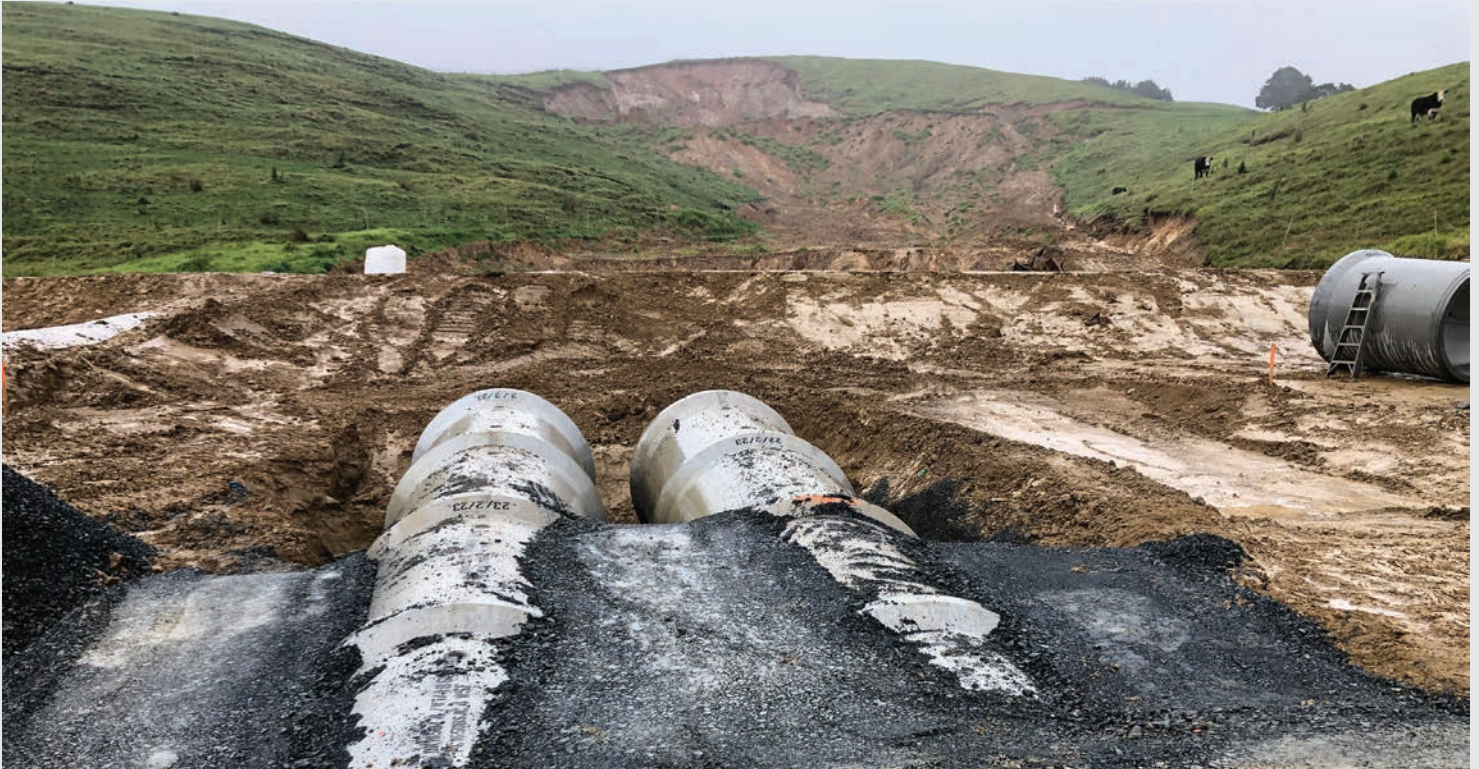
Road culverts being installed. The road bund and new road, will be built on top of them. See the temporary earth bund, to protect the site during construction, and the scarred hillside in the background.

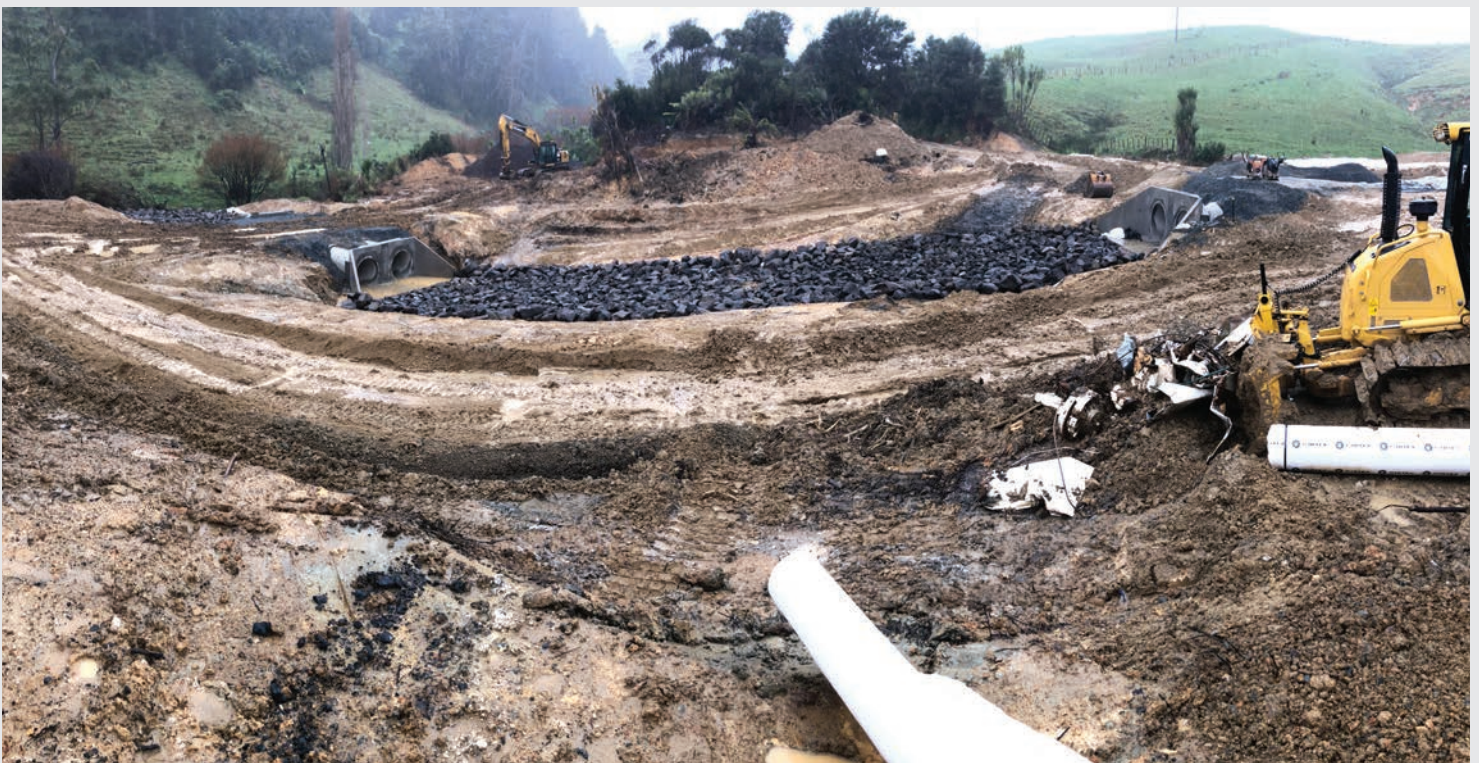
Completion of the graded rock apron in the basin between the road (right) and rail (left) culverts. A large amount of landslip material had to be removed from this area.

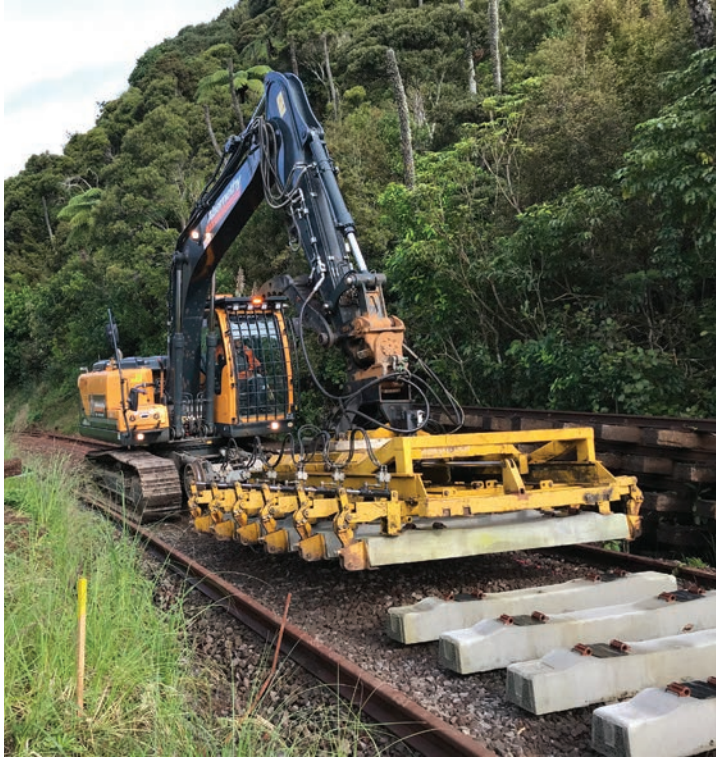
Installing concrete sleepers with sleeper laying frame at Kauri

So far we have laid 11,700 new concrete sleepers – some of which were supplied by Busck in Whangārei - to replace life expired timber sleepers and have laid 7.8km of new rail.

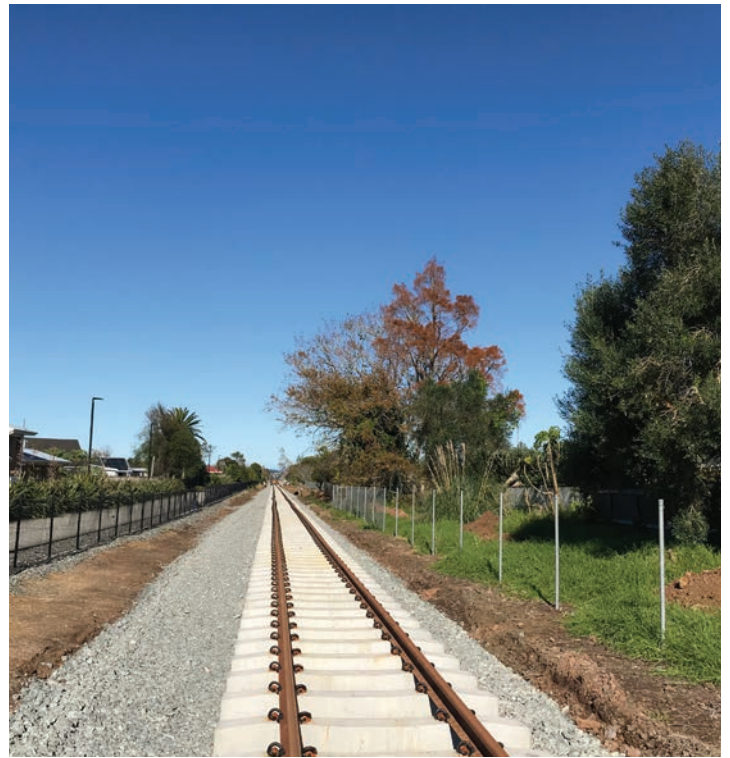
Track laid on ballast bed between Kensington and Kamo Road crossings in Whangārei

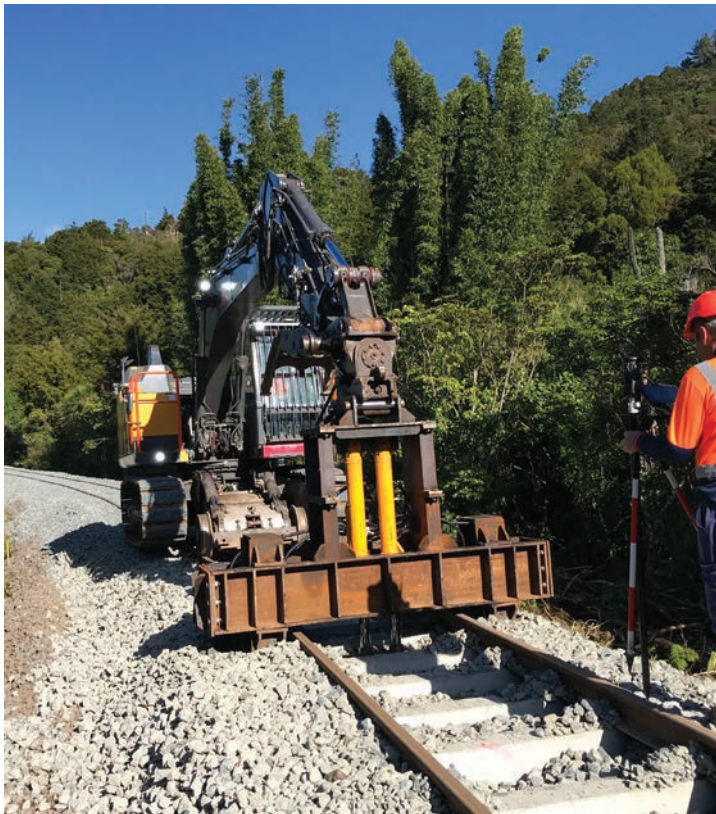
Lifting and alignment of track at Kauri.

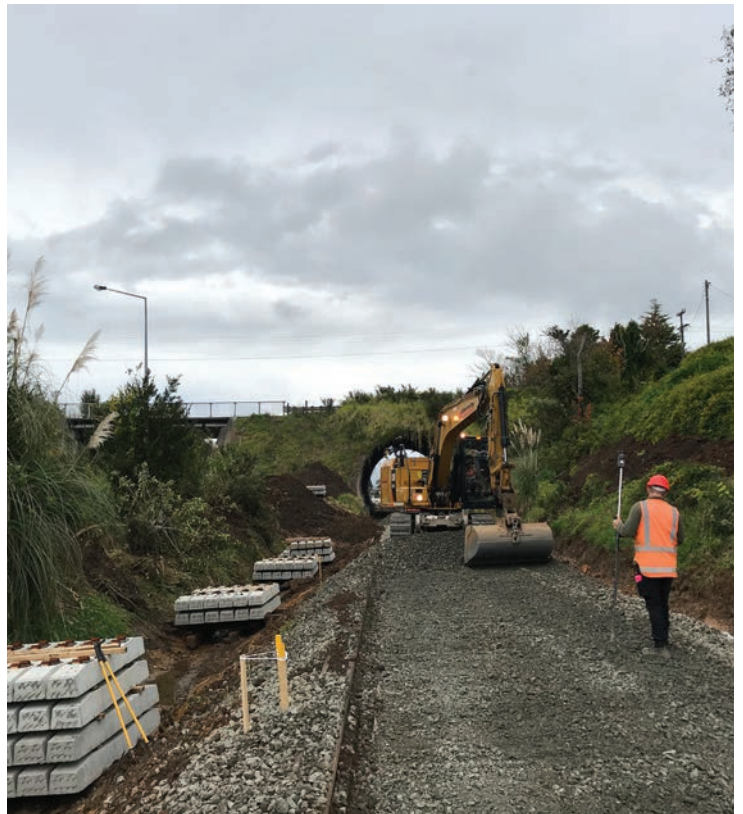
Track renewal and drainage work at Bridge 182 underpass
