Northland Rail Programme

May 2024

Northland Major Damage Sites

Works Map 2023-2024

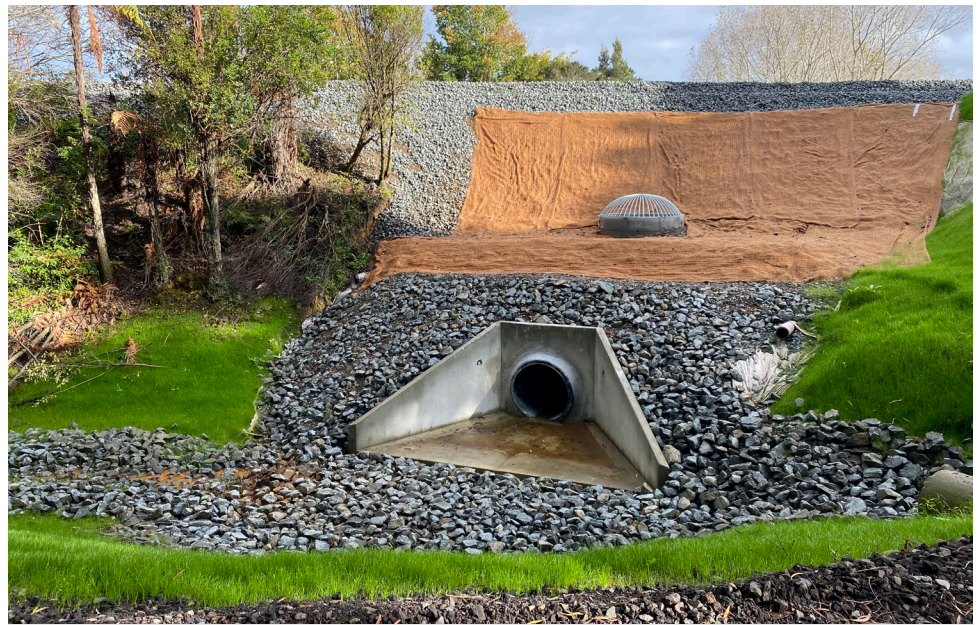
An example of erosion control - improved drainage around the 99km mark, near Woodcocks.

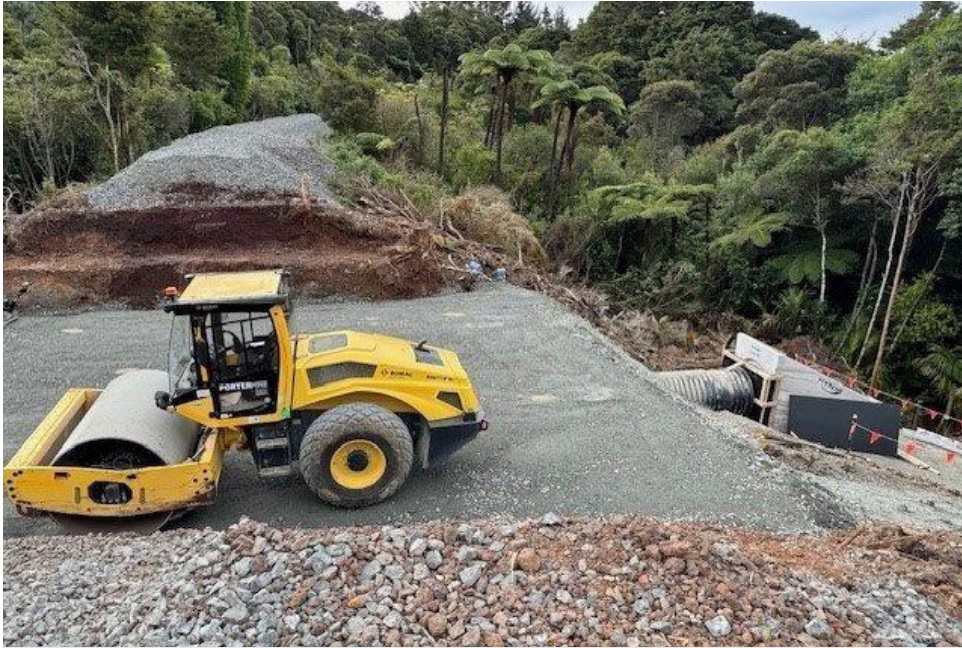
Work progressing at the massive 223km washout site south of Kauri, with a large culvert now installed.

32	152km: 13-metre long unstable slope above the track. COMPLETE
33	160km: 15-metre long shallow landslide, that starts 50 metres from the track. COMPLETE
34	185km: An example of Northland's slip prone geology, where a gentle hillside slumped under the rail line. It has required major excavation and drainage work beneath the tracks and is being rebuilt with sturdier materials. TRACK REINSTATED / SOME ONGOING WORK
35	223km: Major slip south of Kauri. WORK ONGOING

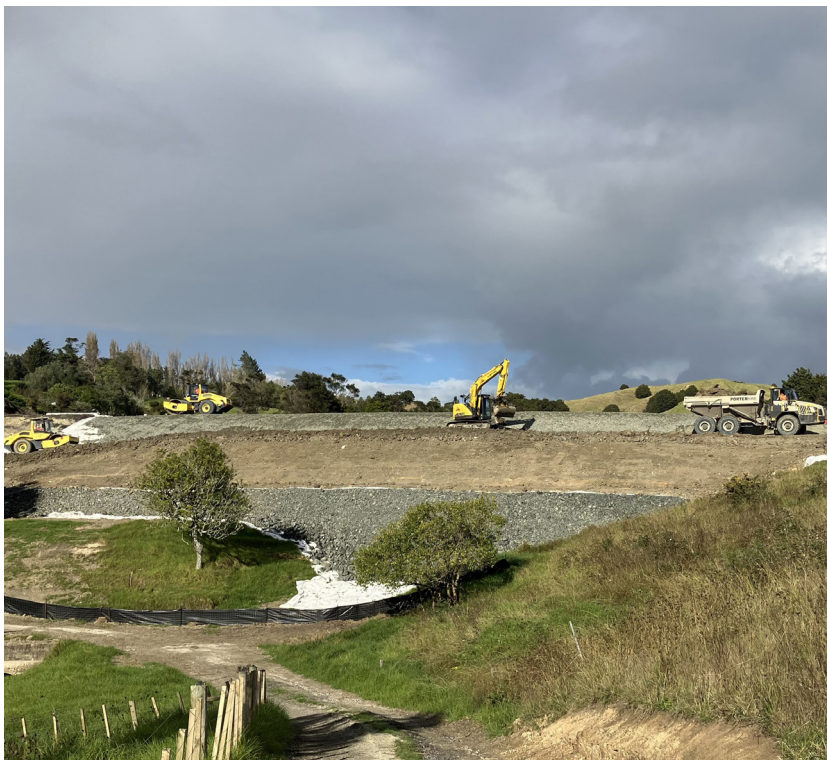
147km rebuild nearing completion, where a huge slip below the rail line caused a 100-metre embankment to fail. About 21,000 cubic metres of saturated material had to be excavated and the embankment rebuilt.

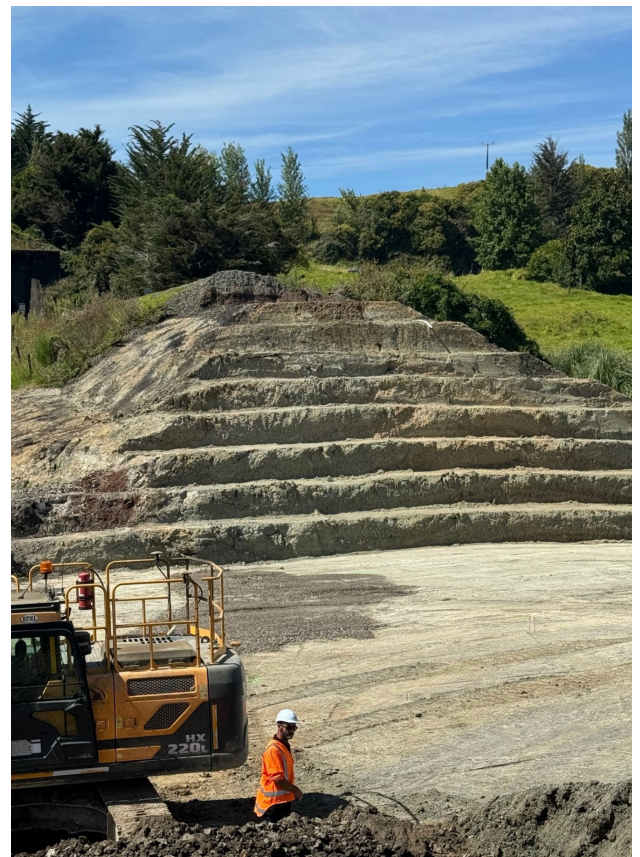
The site in February.

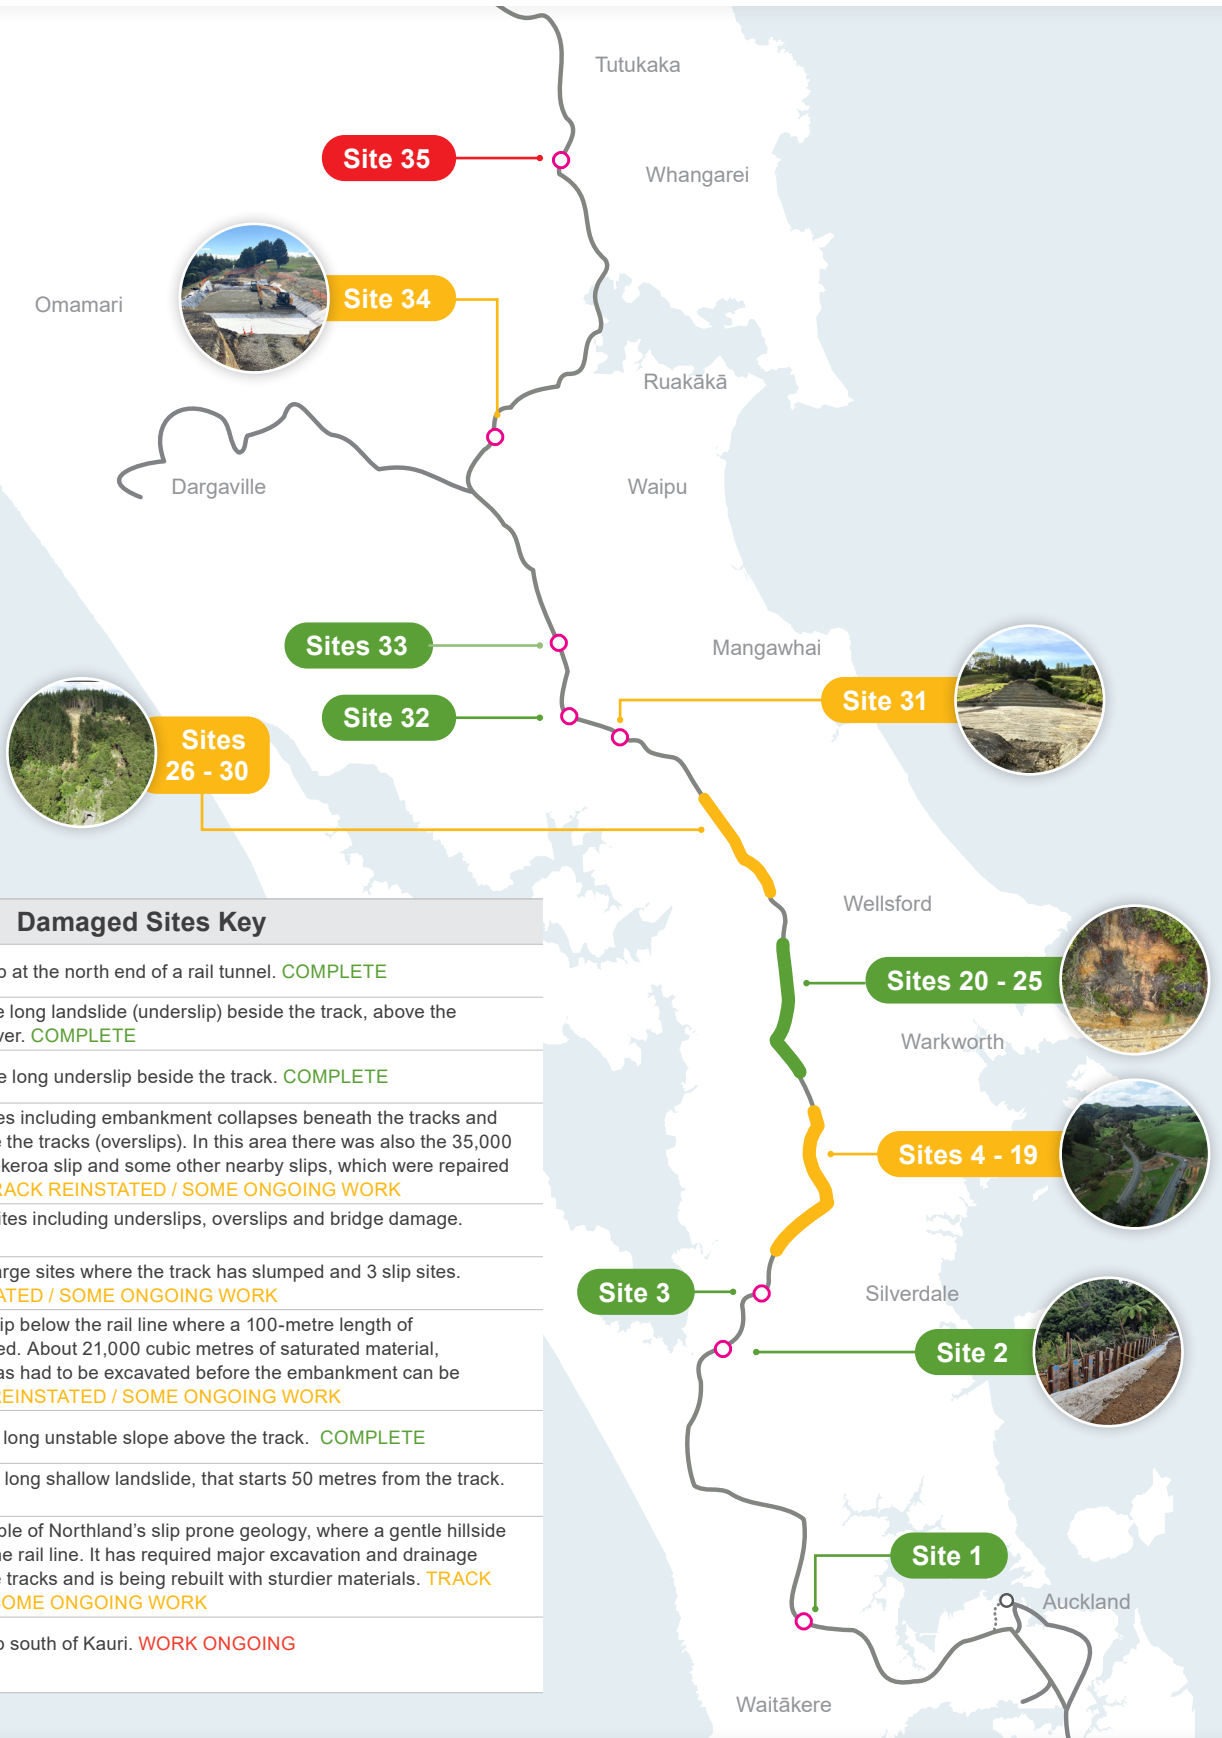
1	34km: A major slip at the north end of a rail tunnel. COMPLETE
2	71km: A 15-metre long landslide (underslip) beside the track, above the Kaukapakapa River. COMPLETE
3	78km: A 20-metre long underslip beside the track. COMPLETE
4 - 19	85 - 99km: 16 sites including embankment collapses beneath the tracks and some slips above the tracks (overslips). In this area there was also the 35,000 cubic metre Tahekeroa slip and some other nearby slips, which were repaired in September. TRACK REINSTATED / SOME ONGOING WORK
20 - 25	104 - 113km: 6 sites including underslips, overslips and bridge damage. COMPLETE
26 - 30	118 - 136km: 2 large sites where the track has slumped and 3 slip sites. TRACK REINSTATED / SOME ONGOING WORK
31	147km: A huge slip below the rail line where a 100-metre length of embankment failed. About 21,000 cubic metres of saturated material, 8-metres deep has had to be excavated before the embankment can be rebuilt. TRACK REINSTATED / SOME ONGOING WORK
