# Northland Rail Programme

## Progress repairing the North Auckland Line

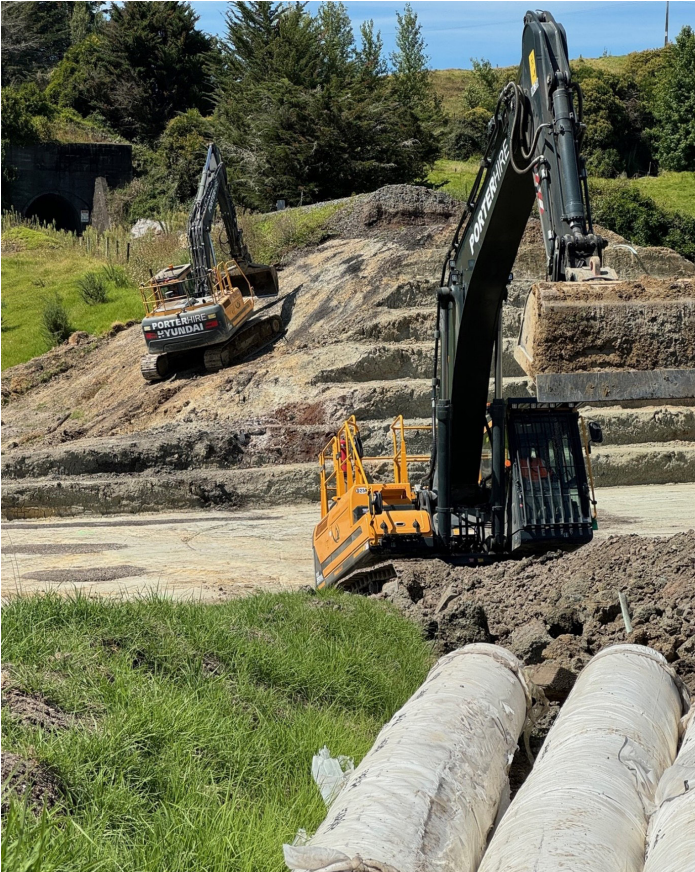
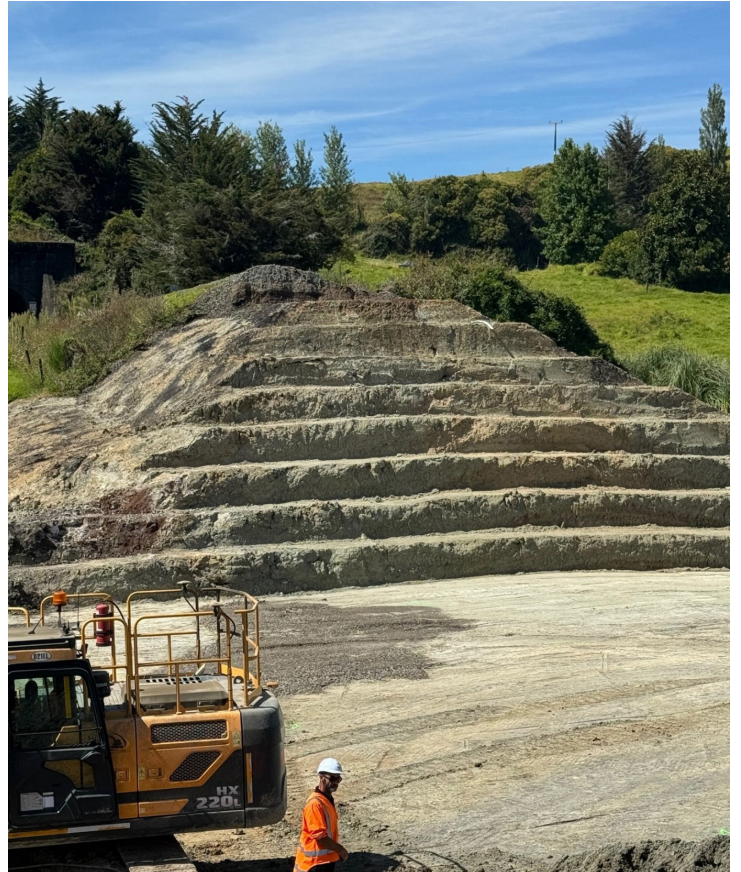
*A massive slip below the rail line north of Ranganui, where a 100 metre length of embankment failed. About 21,000 cubic metres of unsuitable, saturated material, eight metres deep had to be excavated. The grey material on top of the “pyramid” is the ballast that the rail line sits in. The terraces cut into the earth will help tie the existing embankment into the new material which will be laid.*

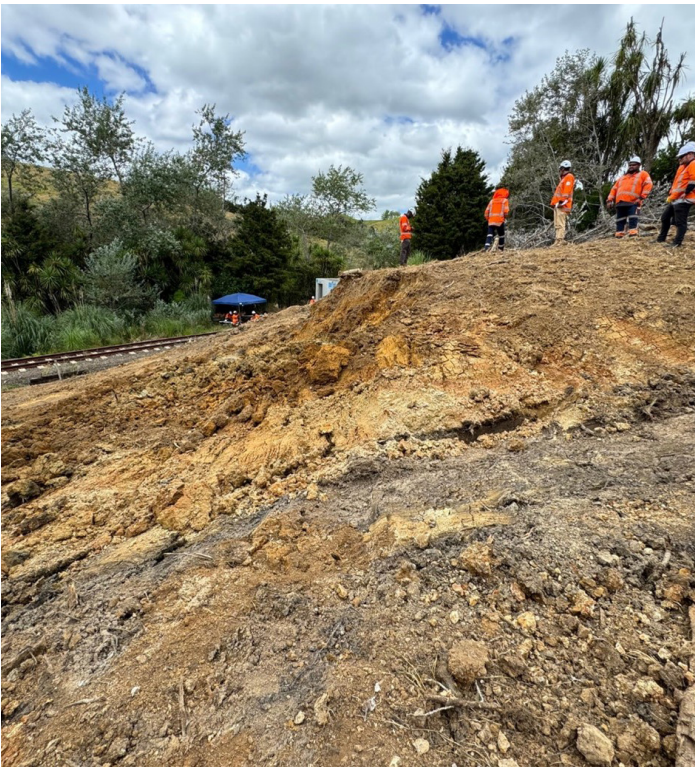
*Work has begun clearing a slumped hillside above the tracks south of Mareretu. Drains will be installed in the slope to help stop more material coming down towards the tracks.*

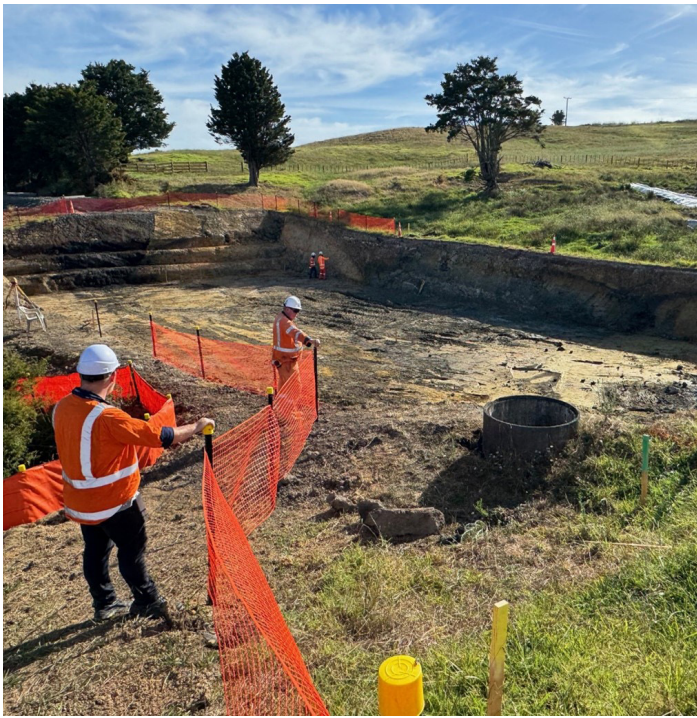
An example of Northland's slip prone geology. The excavation north of Waitira is where a gentle hillside slumped under the rail line. The track and ballast can be seen in the top left corner of the picture. This area will be rebuilt with sturdy material and improved drainage.
