July 2023

Northland Rail Programme

Progress repairing the North Auckland Line

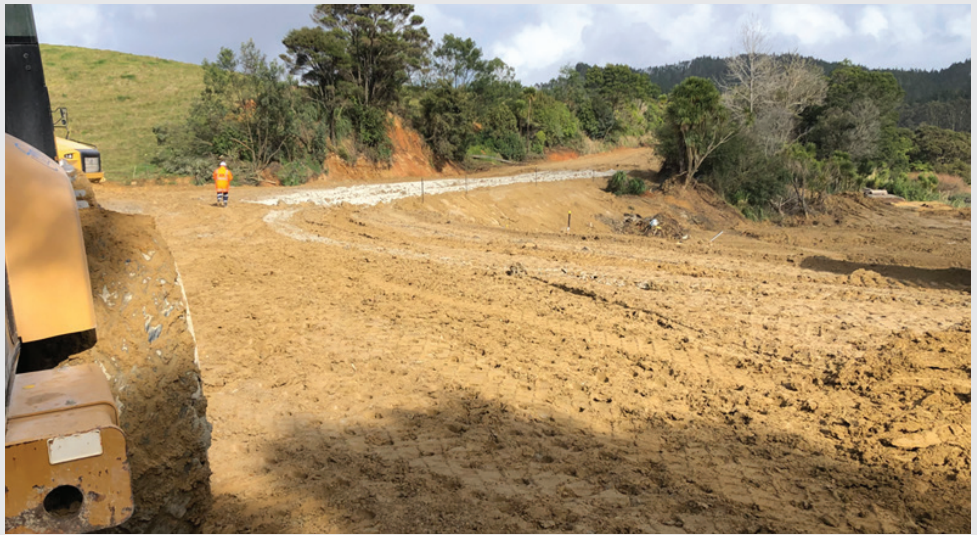
Road embankment under construction – currently approx. 1m cover over the culverts. Lime/cement stabilization has enabled the earthworks to continue through a very wet July.

Civil works, including track formation replacement, at Tahekeroa is expected to be completed by mid – late August, depending on weather. Track installation will follow as soon as possible after that.

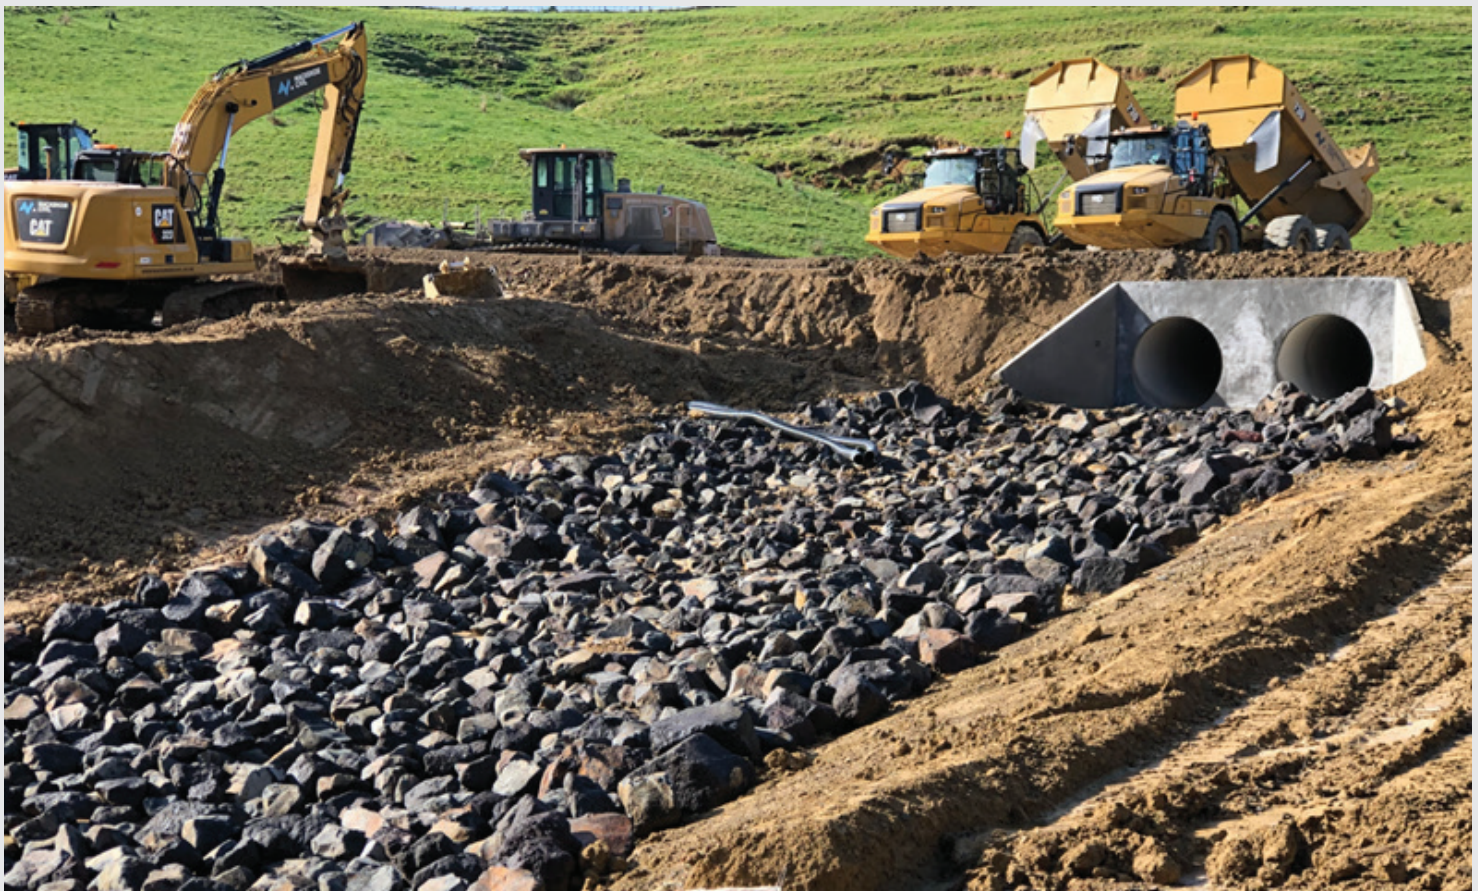
Completion of road and rail culverts and the graded rock apron in the basin between them.

- Repair of two under slip sites very close to Tahekeroa and remediation of a scoured embankment just to the east of the landslide have been completed. An existing, aging culvert under the rail line in the area is also being replaced with a larger version.
- The installation of both rail and road culverts at the Tahekeroa slip site is complete, with the associated rock apron for scour control also finished.
- Works to construct the road embankment, with a finished level of nearly four metres over the culverts, is now approximately 60% complete.
- Work is underway rebuilding the rail line, with formation (the rock foundation under the tracks) reconstruction progressing in parallel with the road embankment work.

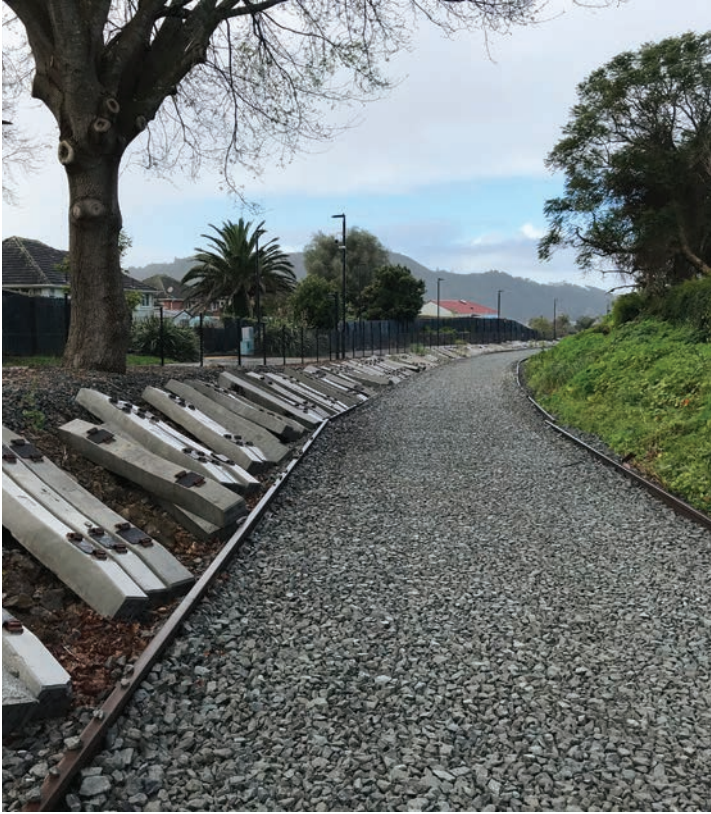
Ballast bed completed between Kamo Road and State Highway 1

So far we have laid 14,600 new concrete sleepers – some of which were supplied by Busck in Whangārei - to replace life expired timber sleepers and have laid 9.5km of new rail.

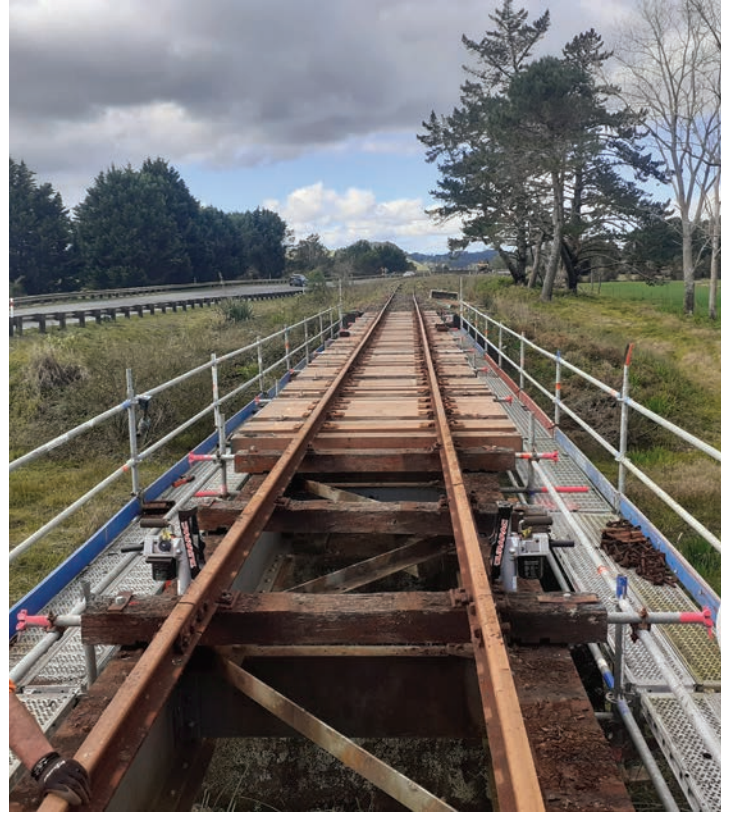
New sleepers being laid on Bridge 201

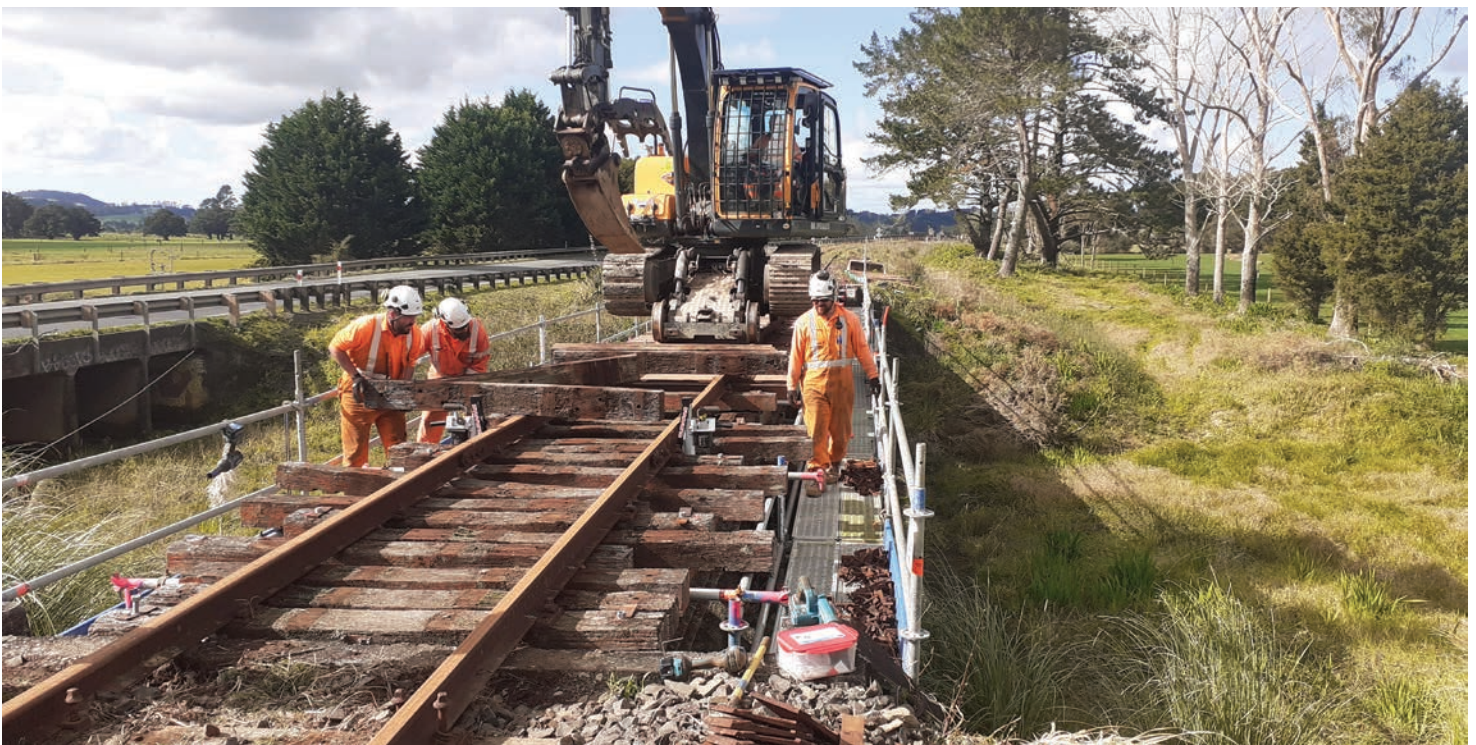
Removing old sleepers from Bridge 201
