## Tahekeroa construction facts

## Progress repairing the North Auckland Line

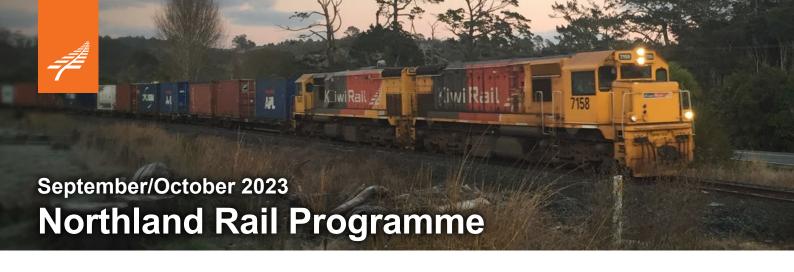
The 390m long slip at Tahekeroa – before and after

We have completed work fixing the massive 35,000m3 slip at Tahekeroa, north of Auckland, which fell across the road and rail line and the road has been reopened.

We have done more than just rebuilt what was there. We've re-engineered the area to improve drainage and significantly improve resilience, in case of future weather events.

The new road is raised more than four metres, with large culverts that run underneath into a basin area, and another set of culverts under the rail line. Not only will this enable water to flow quickly away from the site, but if there is another slip the raised road will act as a barrier and the basin will be able to capture slip material before it reaches the rail line.

• reusing 95 per cent of the slip material to stabilise the area – avoiding emissions, congestion and road wear and tear from more than 6,000 truck trips to landfill

• the new 4 metre-high road embankment is made up of this re-purposed landslide material

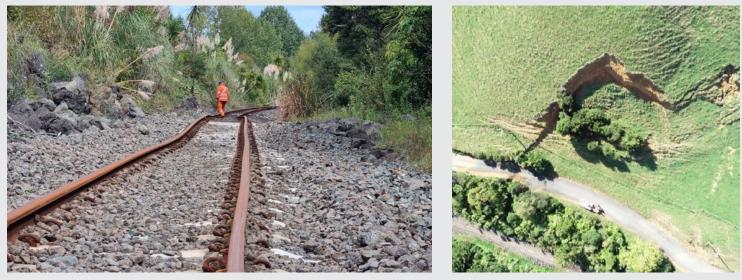
Rail line north of Tahekeroa, at the base of a large slip. We need to understand what is happening below ground.

While the rail line 2km north of Tahekeroa only looks slightly lumpy, with a kink, it is actually at the bottom of a large slip. Before we can make any repairs, we need to understand what is happening with the slip and whether the earth movement continues under the line so that heavy freight trains won't make it worse. We have undertaken a lot of core sampling to understand the geology and are designing an engineering response that will ensure safety.
