MELLING COLLISION

15 April 2013

EXECUTIVE SUMMARY

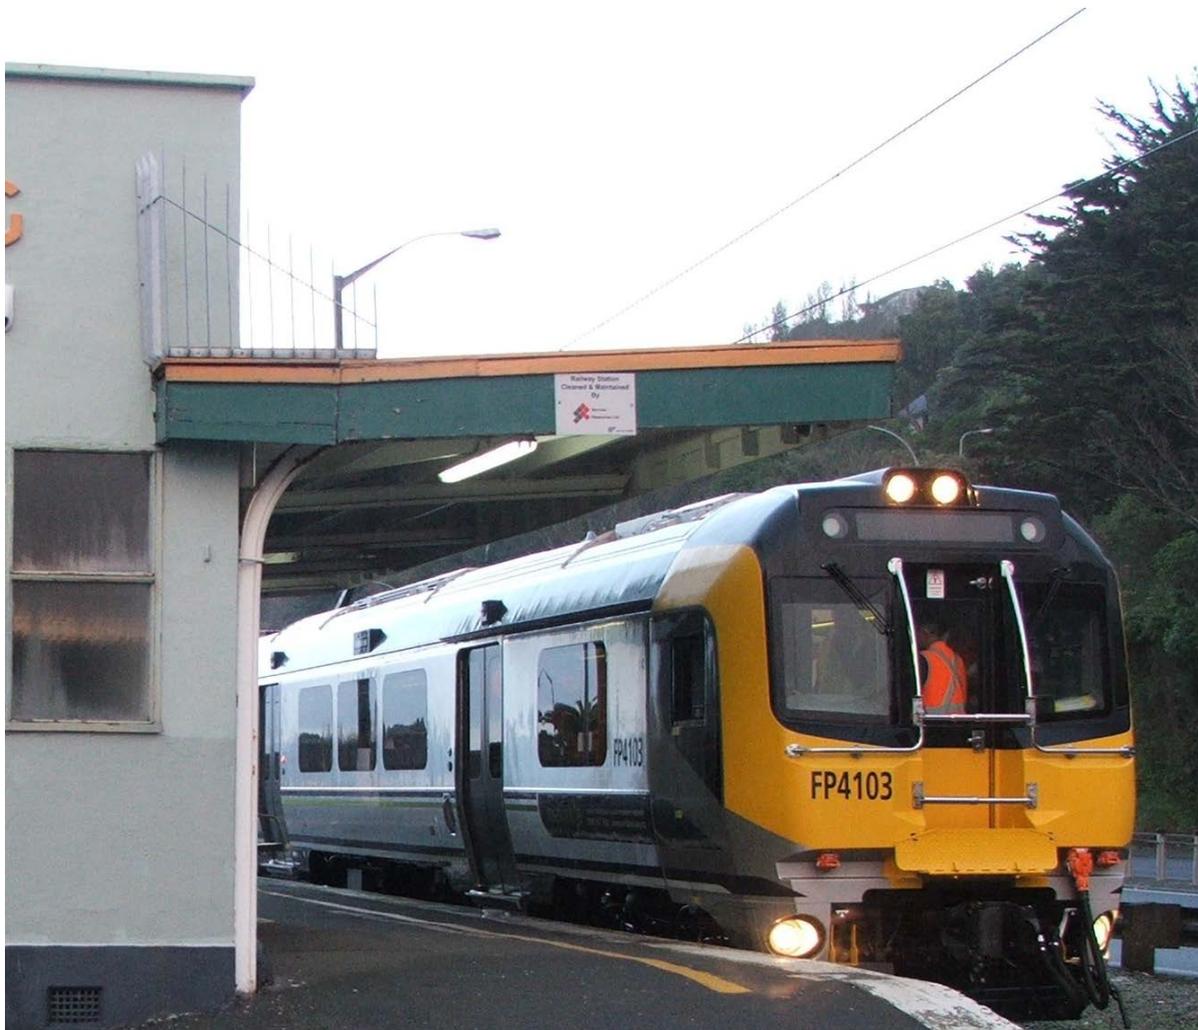
On 15 April 2013, at approximately 7:54am, an incident occurred when a two-car Matangi service failed to stop and collided with the stop block at Melling Station.

- There was no mechanical fault on the Matangi unit which collided with the stop block at a speed of approximately 25km/h.
- All of the unit's components - brakes, coupling, and catcher - functioned correctly as they were designed.
- The driver had applied braking which was insufficient to stop the train and applied the emergency braking system immediately before impact with the stop block.
- The data downloaded from the train's Tranzlog (the equivalent of the black box on an aircraft) showed that the braking systems operated as they were designed.
- Therefore the cause of the incident was driver error.
