Northland Rail Programme Newsletter

Progress repairing the North Auckland Line

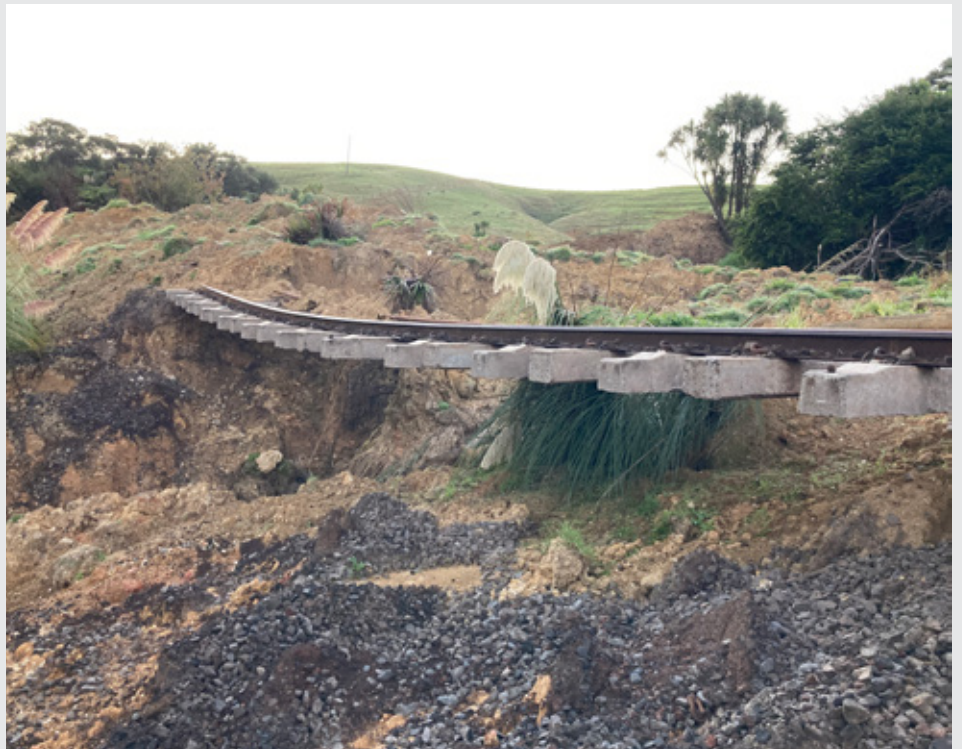
North Auckland - slip covered rail line at Tahekeroa

Enabling works for the Tahekeroa slip are complete, including clearing construction vehicle access right through the site. The removal of slip material is well underway - to date more than 3,500 cubic metres of earth has been removed from the site. Construction of a temporary bund to protect site works is underway and access is currently being cleared to enable clearing of the rail line. All going well we are hoping to get a work train to the site, and begin repairing the line, around mid-May.

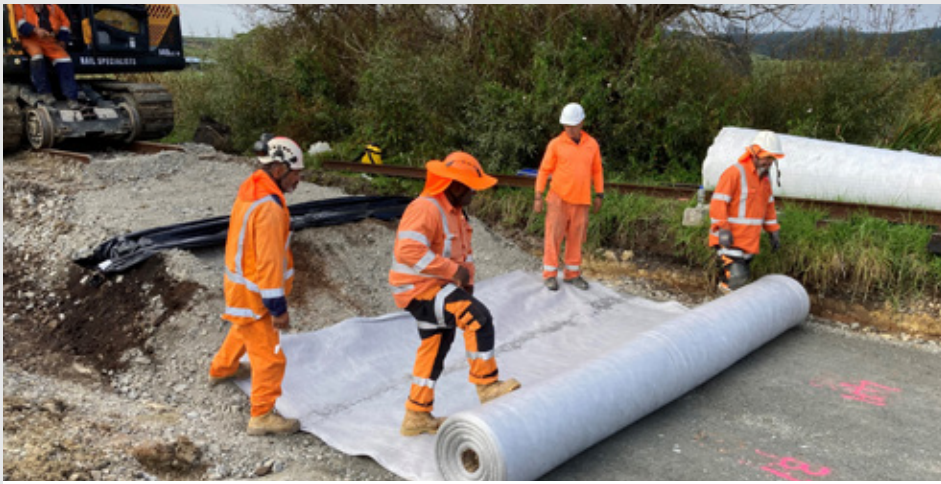
North Auckland - laying down geotech cloth prior to laying ballast at Woodhill

We have removed numerous fallen trees and smaller slips along the line between Swanson and Whangārei and made excellent progress repairing the track south of Makarau. There was significant flooding in that part of the region, which undermined large sections of track and washed away large amounts of ballast. We have now repaired major washouts at Waimauku, Woodhill and both south and north of Helensville – adding rock protection beside the tracks (see pictures on the next page).

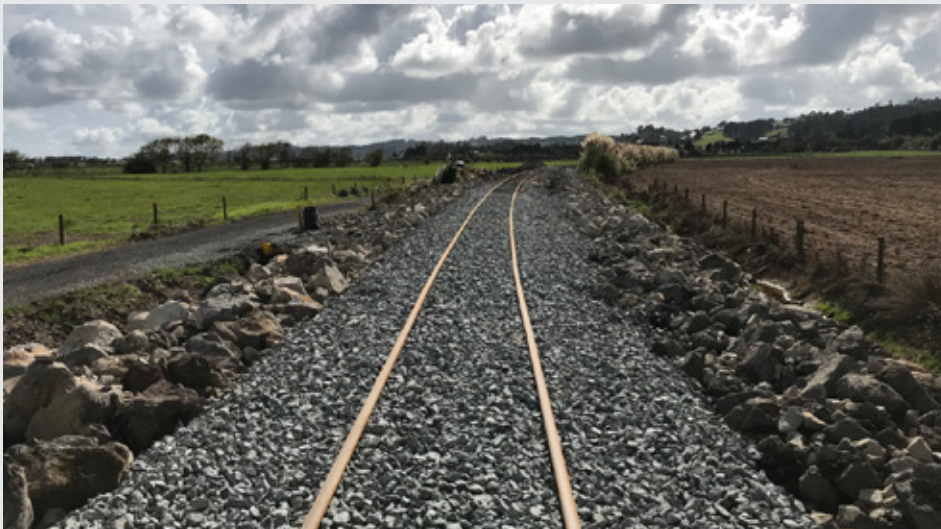
North Auckland - repaired line with rock protection after washouts south of Helensville

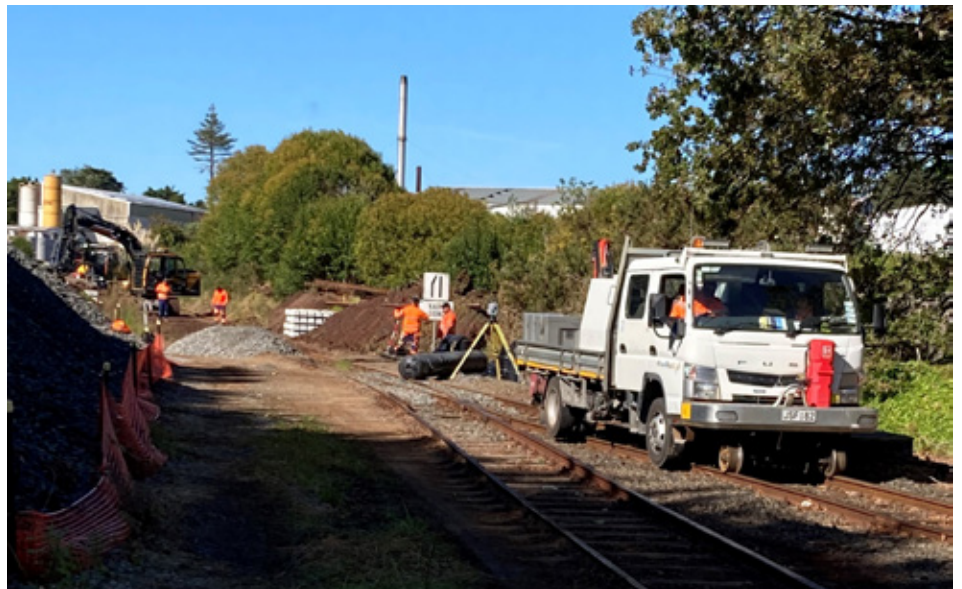
Northland - work getting underway to upgrade the rail line near Kauri

We are replacing replacing ballast, sleepers, and rail, to raise the standard of the line - as we have done in recent years when upgrading the track between Swanson and Whangārei to an 18-tonne axle load.
